8 Quail Place Hamilton Lake Hamilton New Zealand

Cavity Fix Nailing Setout Detail

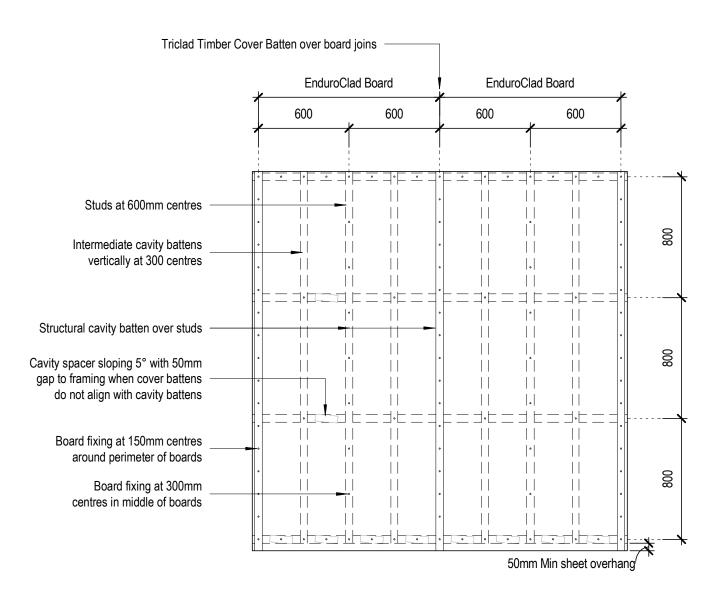
1:25@A4
 Dec 2019
 Fig 2a

Where cover battens do not sit over a stud it is recommended that additional nogging is used to provide additional fixing for the decorative cover battens.

Cavity Fix Framing/Batten Setout-600mm

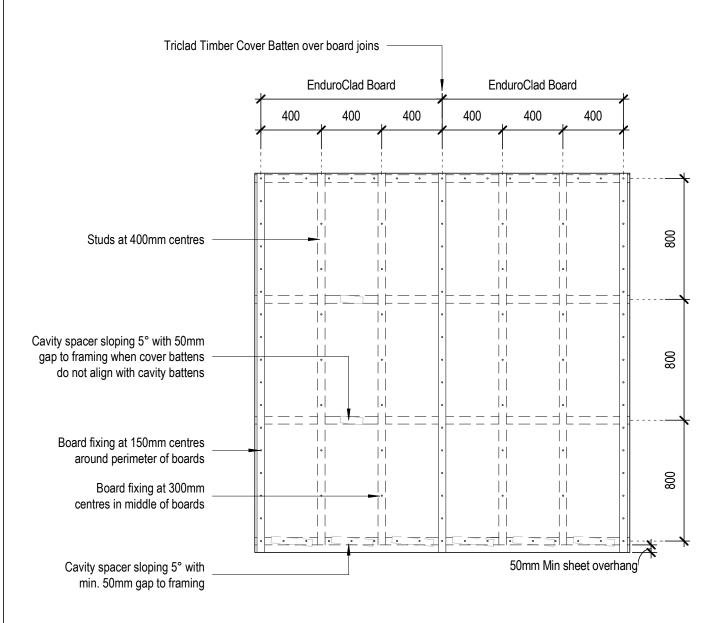
1:25@A4
 Dec 2019
 Fig 2b

Where cover battens do not sit over a stud it is recommended that additional nogging is used to provide additional fixing for the decorative cover battens.

Cavity Fix Framing/Batten Setout-400mm

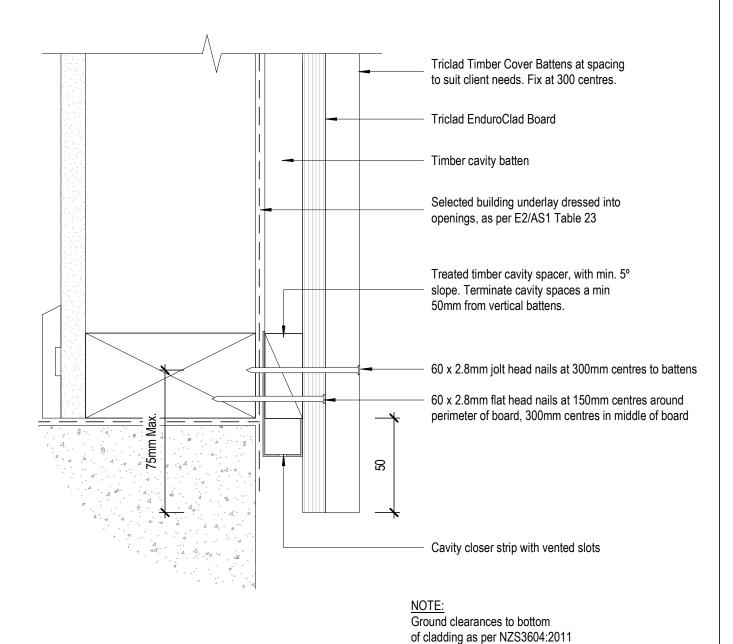
1:2@A4
 Dec 2019
 Fig 3

Cavity Fix Base Detail-Concrete Floor

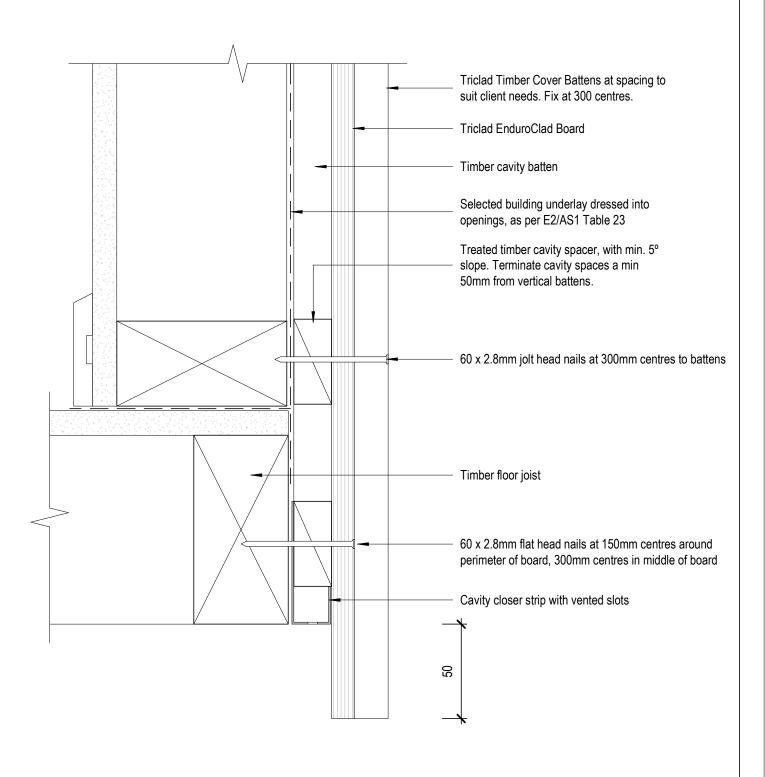
1:2@A4
 Dec 2019
 Fig 4

Cavity Fix Base Detail-Timber Floor

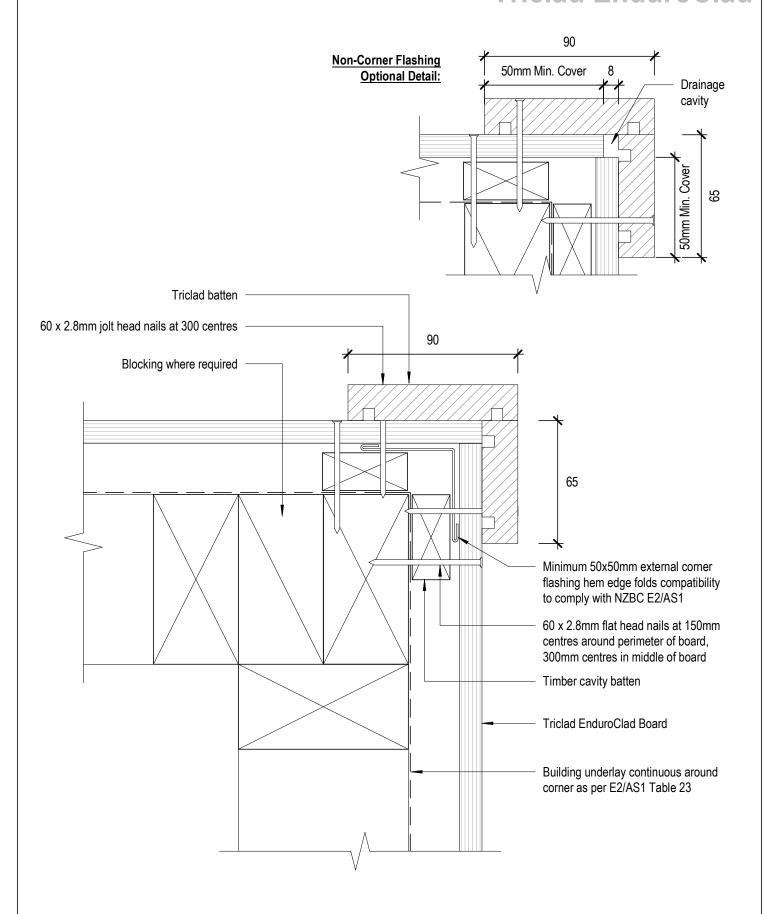
1:2@A4
 Dec 2019
 Fig 5

Cavity Fix External Corner-Boxed

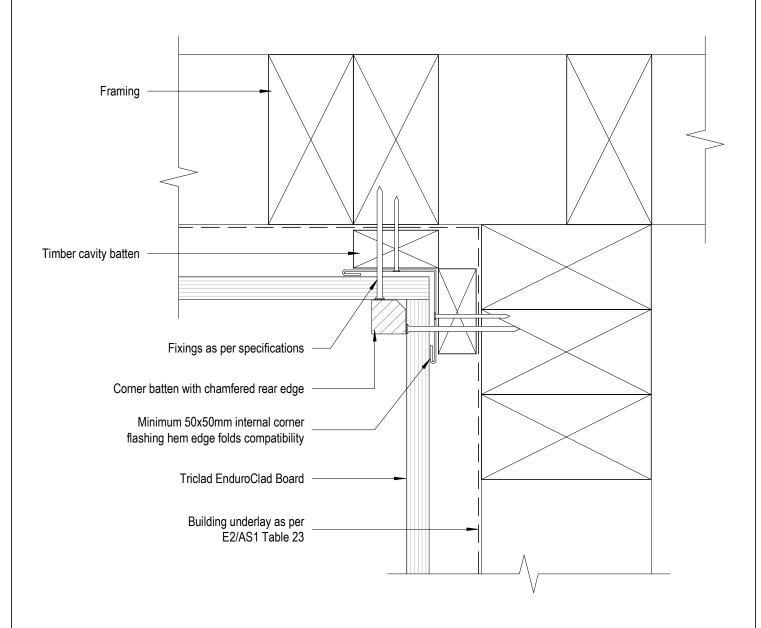
1:2@A4
 Dec 2019
 Fig 6

Cavity Fix Internal Corner

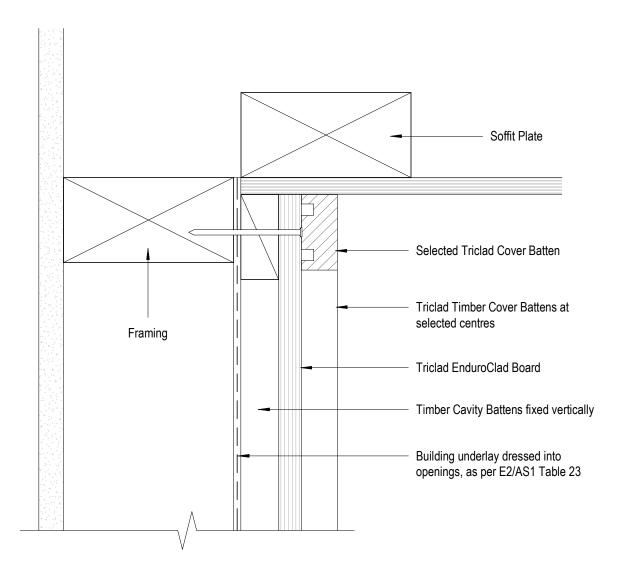
1:2@A4
 Dec 2019
 Fig 7

Cavity Fix Soffit Detail

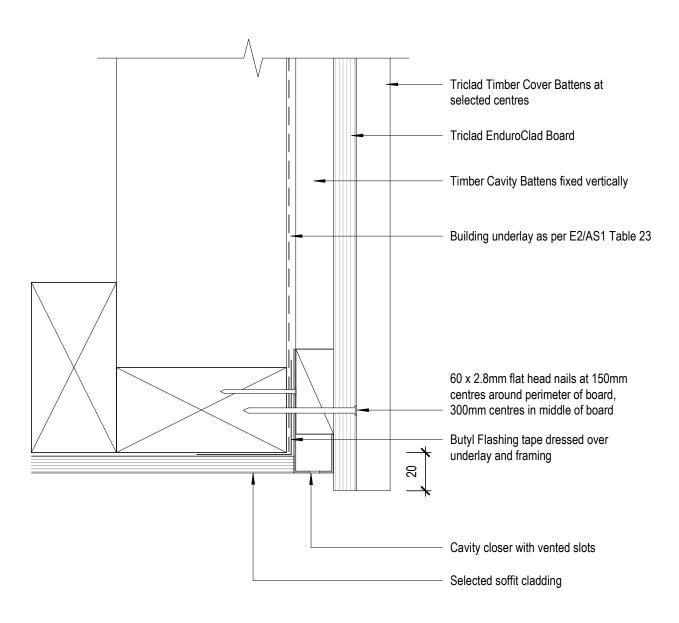
1:2@A4
 Dec 2019
 Fig 8

Cavity Fix Soffit/Beam Detail

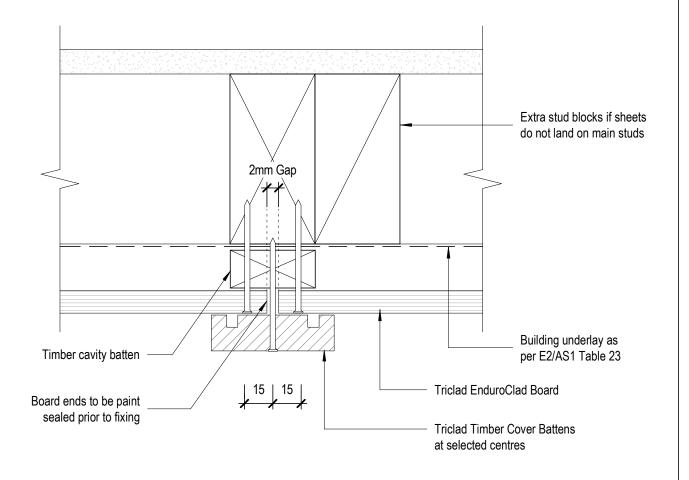
1:2@A4
 Dec 2019
 Fig 9

Cavity Fix Board Joint Detail

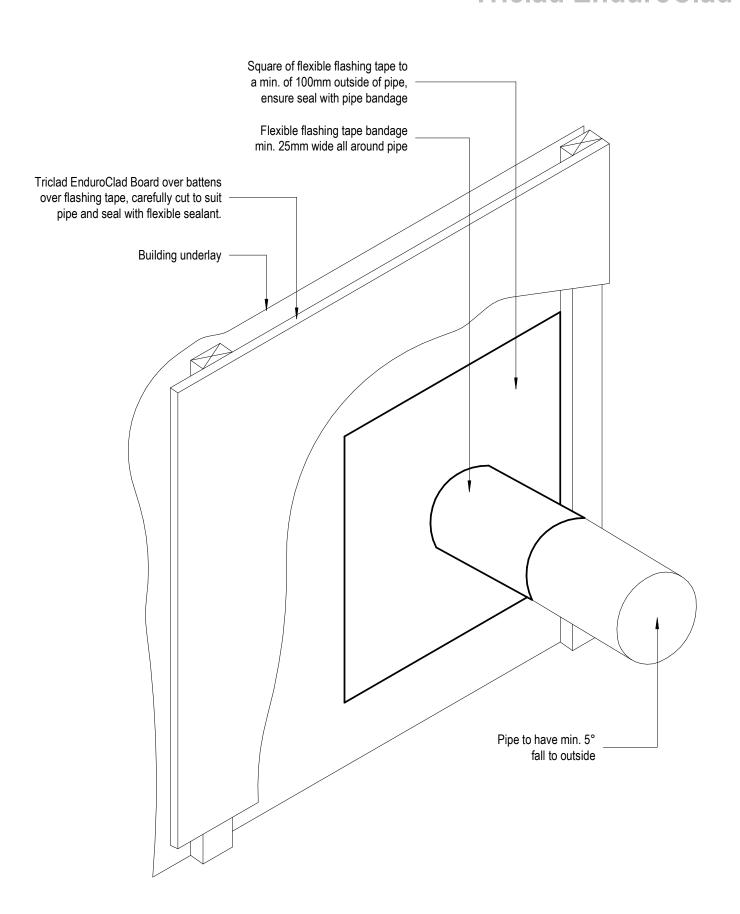
1:5@A4
 Dec 2019
 Fig 10

Cavity Fix Penetration Detail

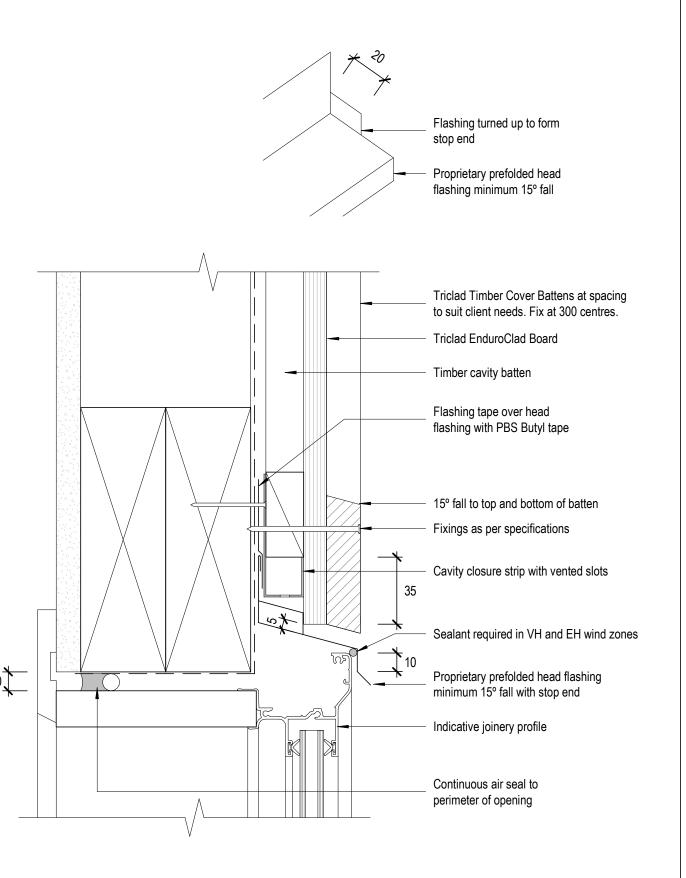
1:2@A4
 Dec 2019
 Fig 11

Cavity Fix Window Head Detail-Aluminium

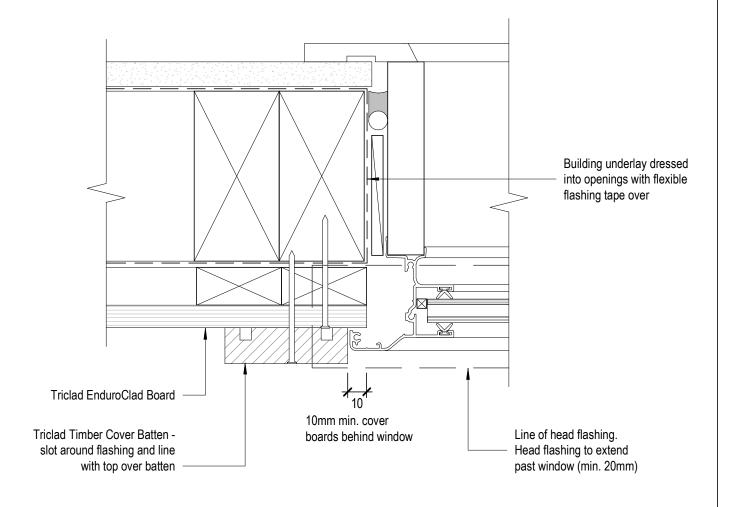
1 : 2 @ A4
 Dec 2019
 Fig 12

Cavity Fix Window Jamb Detail-Aluminium

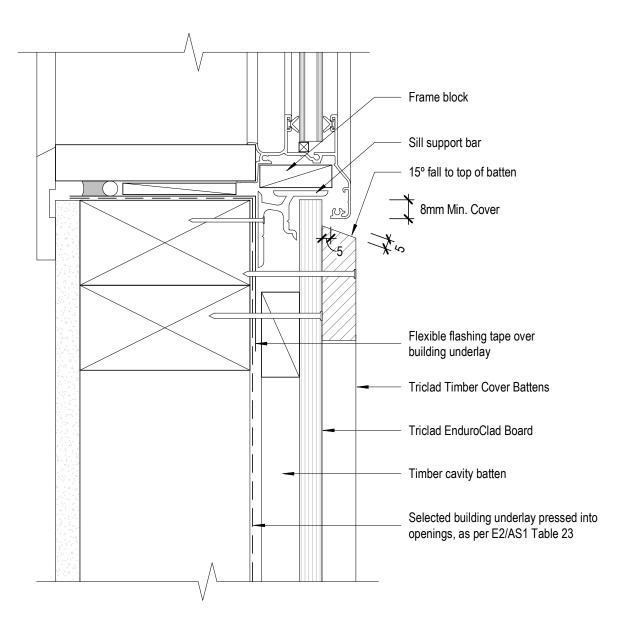
1:2@A4
 Dec 2019
 Fig 13

Cavity Fix Window Sill Detail-Aluminium

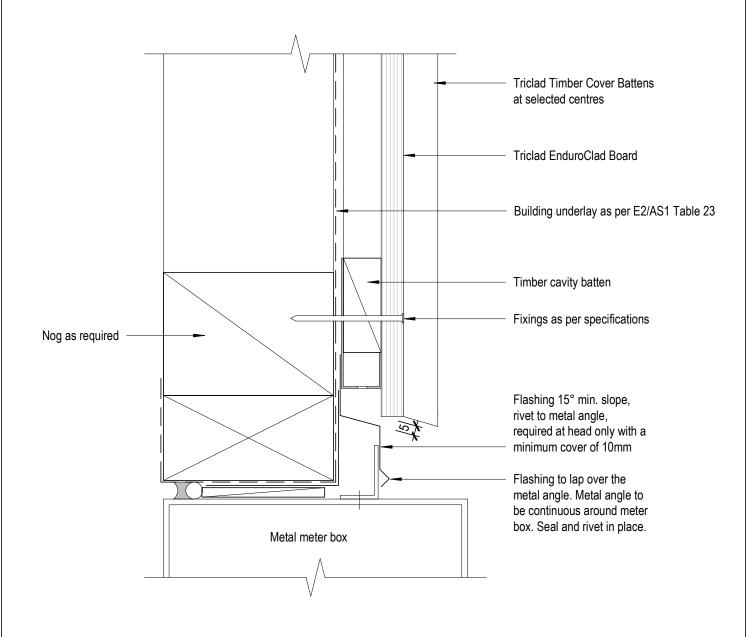
Fig 14 Dwg

Cavity Fix Meter Box Head

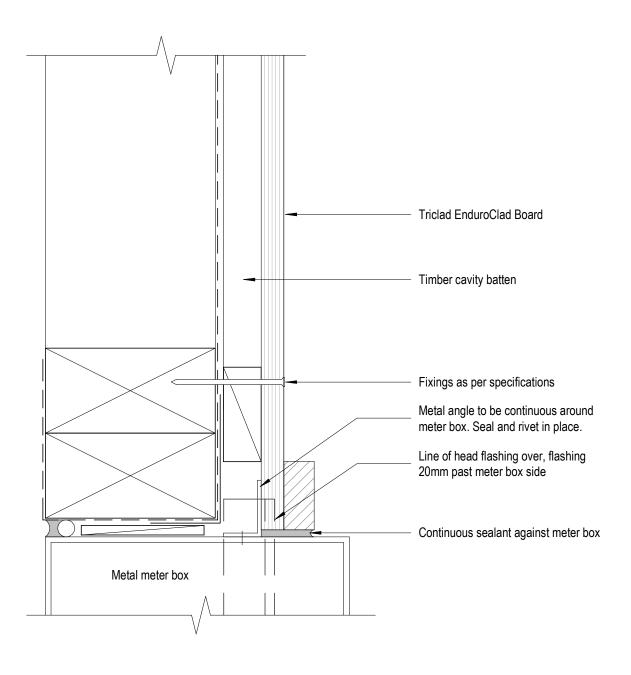
1 : 2 @ A4
 Dec 2019
 Fig 15

Cavity Fix Meter Box Jamb

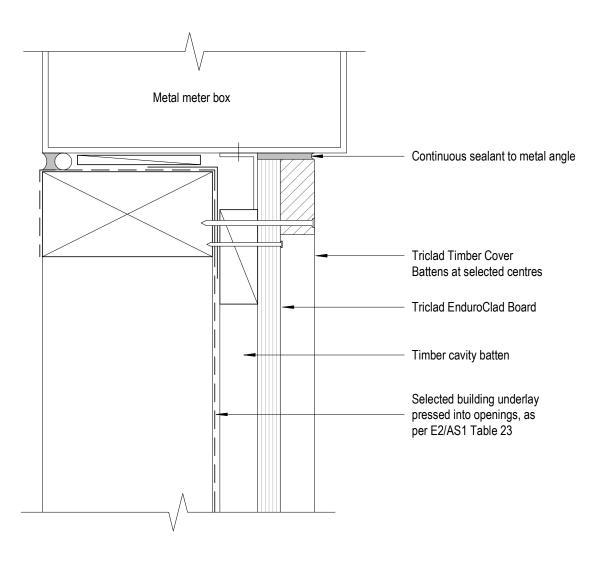
Fig 16

Cavity Fix Meter Box Sill

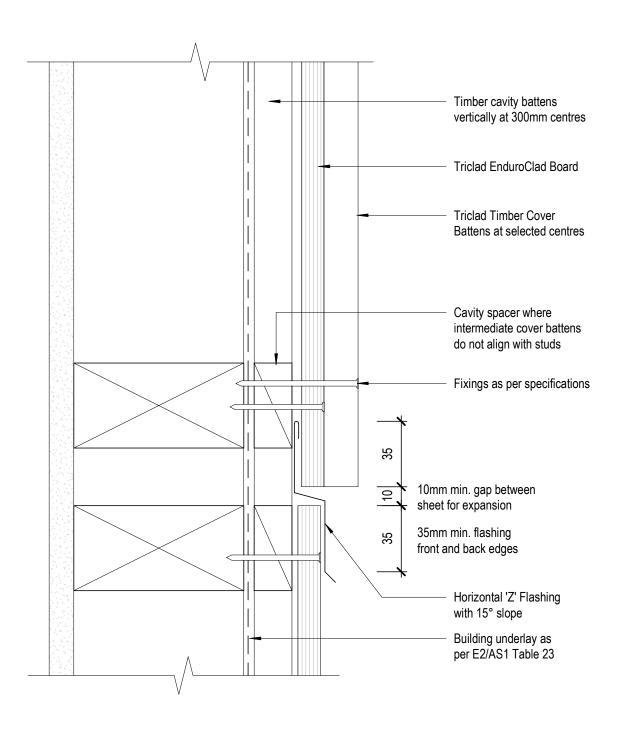
1 : 2 @ A4
 Dec 2019
 Fig 18

Cavity Fix Horizontal Join Detail

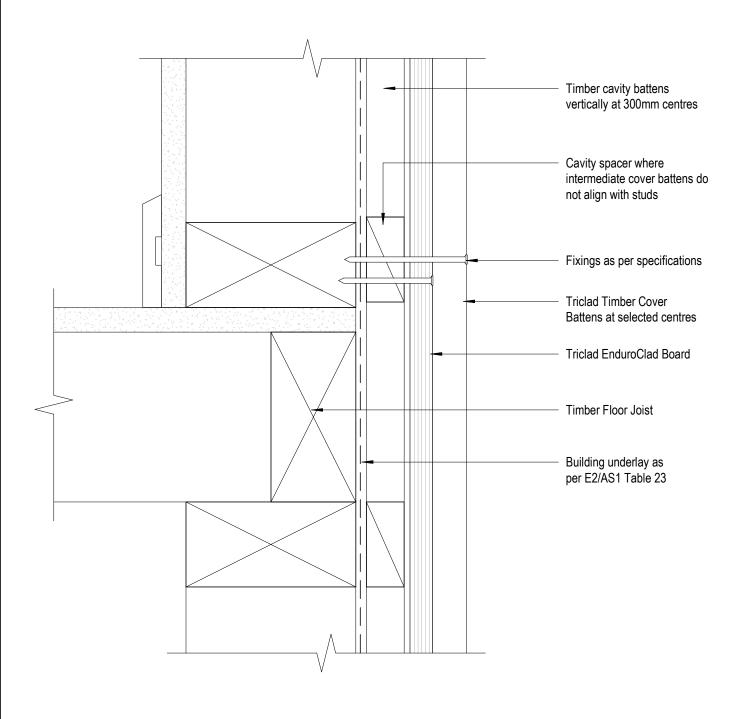
Dec 2019 Date **Fig 18a** Dwg

Cavity Fix Inter-Story Detail - No Join

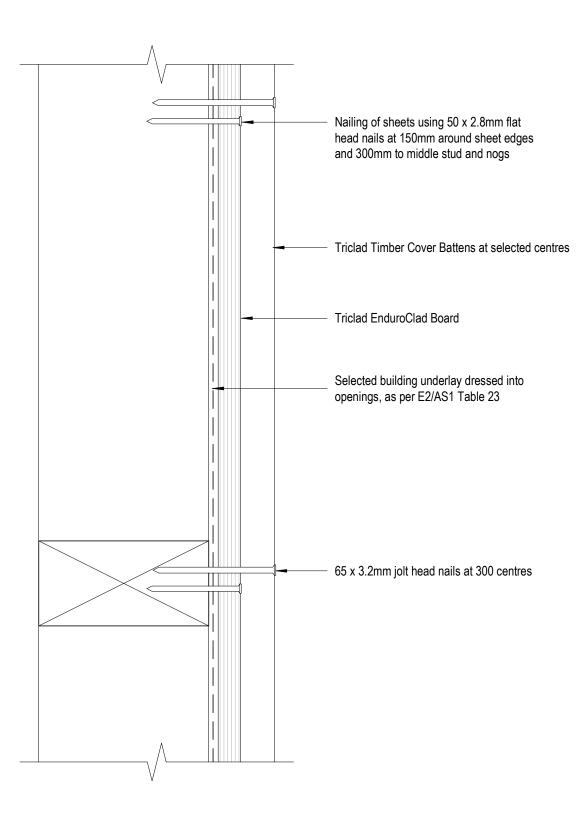
1 : 2 @ A4
 Dec 2019
 Fig 19

Direct Fix Nailing Setout

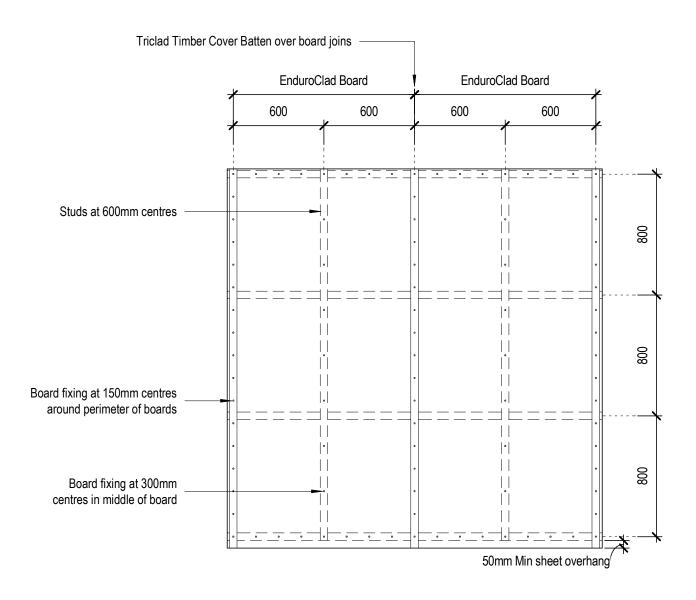
1:25@A4
 Dec 2019
 Fig 20

Where cover battens do not sit over a stud it is recommended that additional nogging is used to provide additional fixing for the decorative cover battens.

Direct Fix Framing/Batten Setout

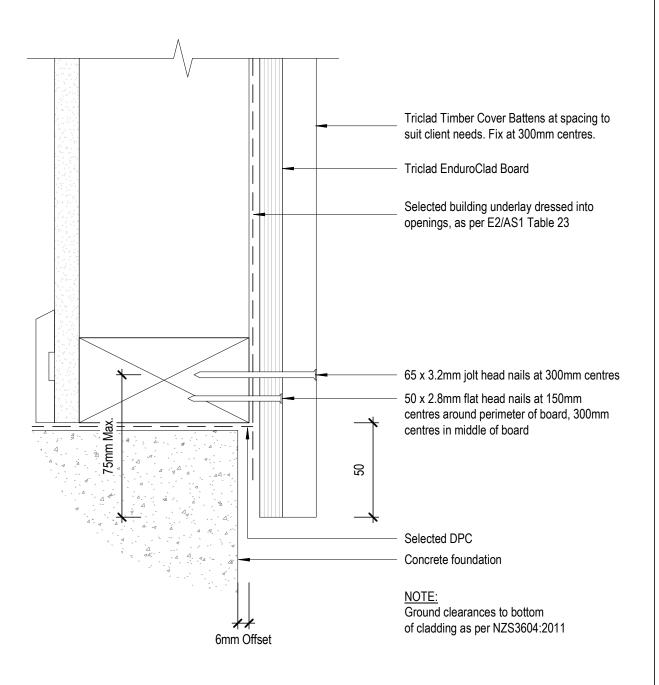
1 : 2 @ A4
 Dec 2019
 Fig 21

Direct Fix Base Detail-Concrete Floor

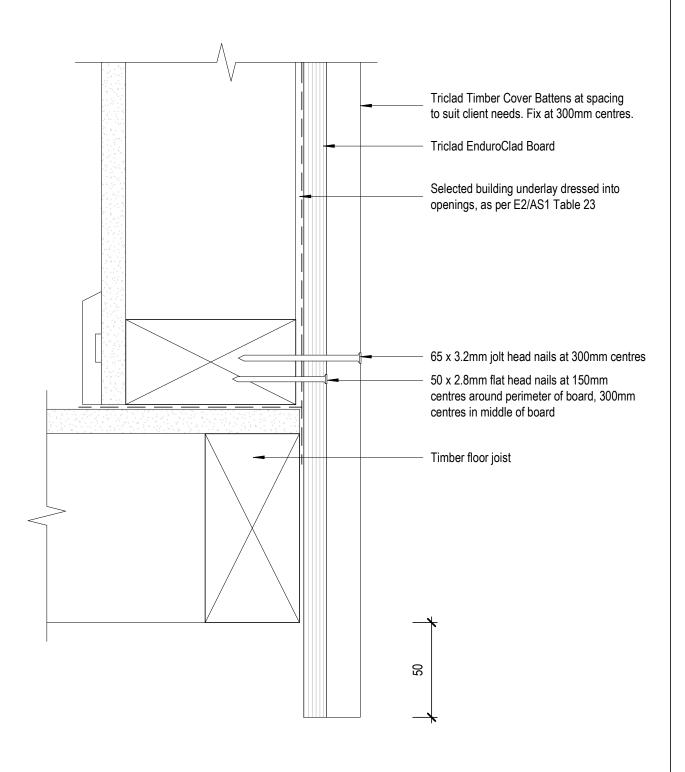
1:2@A4
 Dec 2019
 Fig 22

Direct Fix Base Detail-Timber Floor

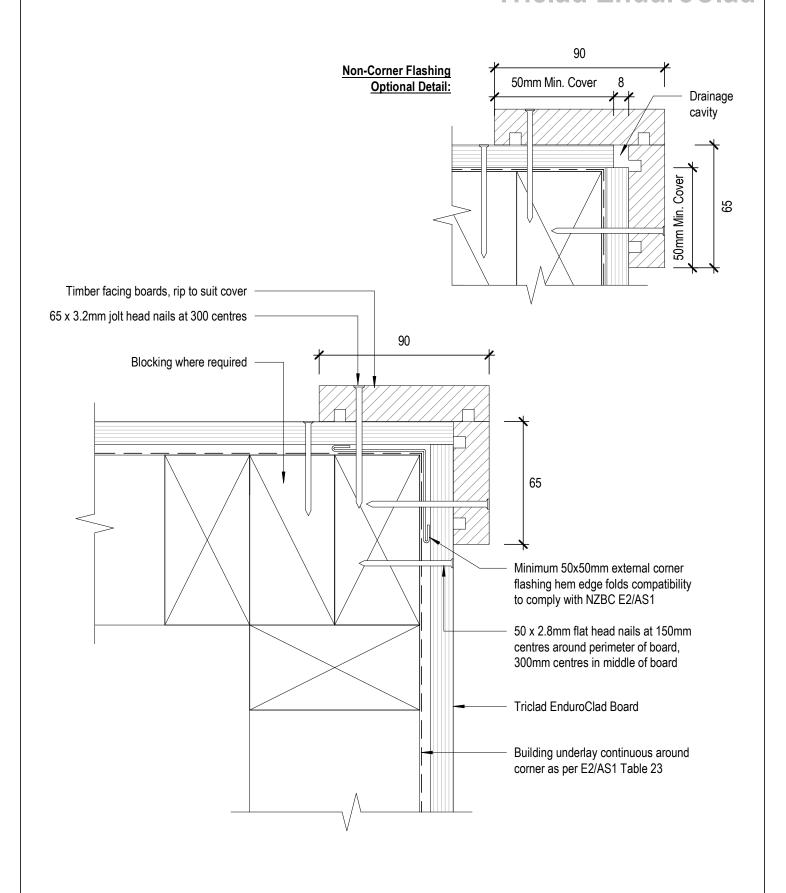
1:2@A4
 Dec 2019
 Fig 23

Direct Fix External Corner-Boxed

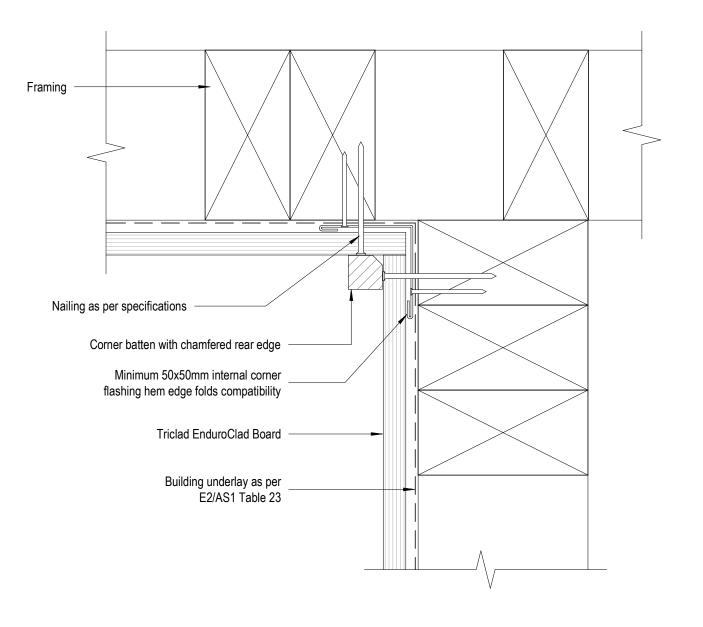
1:2@A4 Dec 2019 Fig 24 Scale Date Dwg

Direct Fix Internal Corner

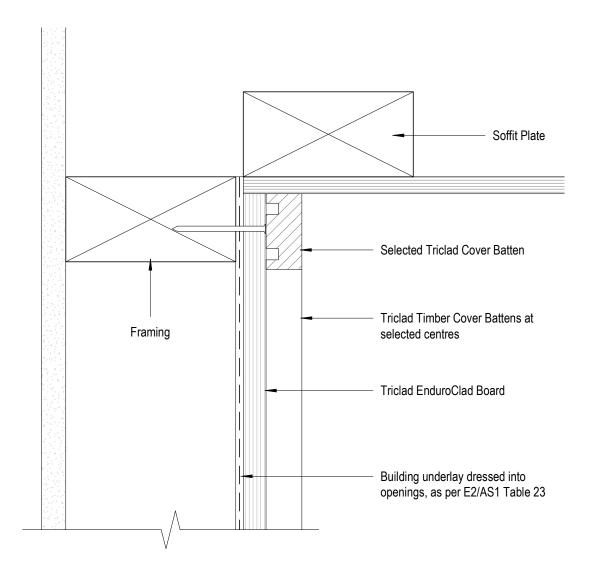
1:2@A4 Dec 2019 Scale Date Fig 25 Dwg

Direct Fix Soffit Detail

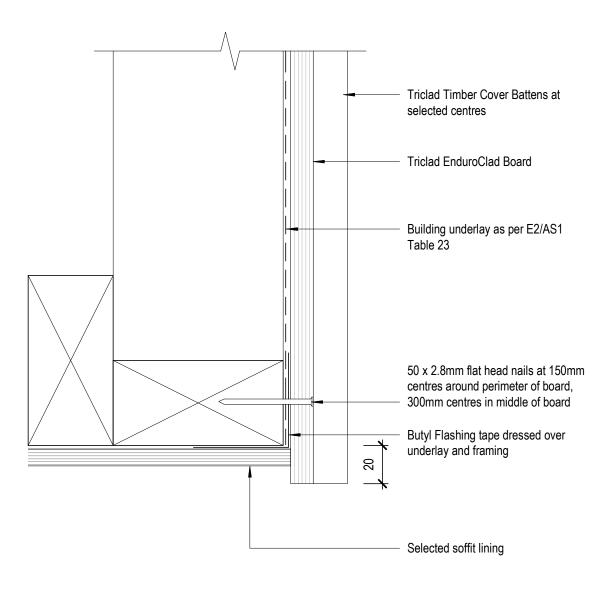
1:2@A4
 Dec 2019
 Fig 26

Direct Fix Soffit/Beam Detail

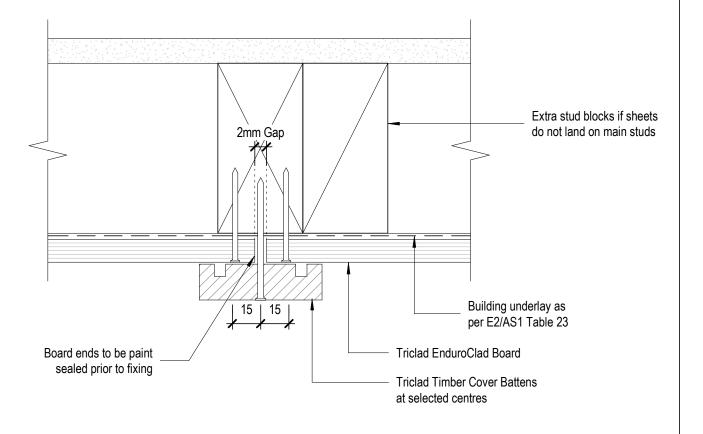
1 : 2 @ A4
 Dec 2019
 Fig 27

Direct Fix Board Joint Detail

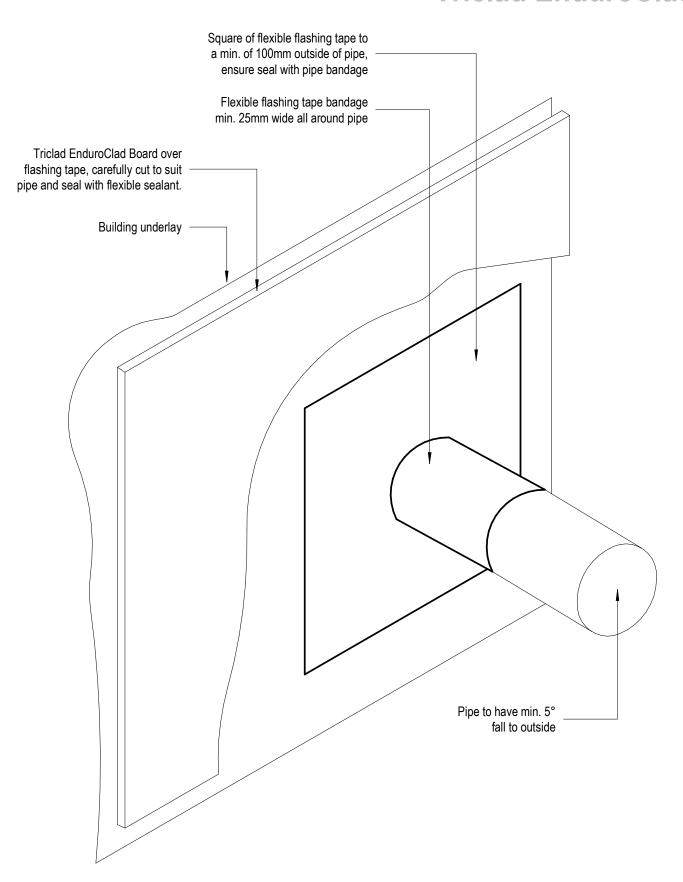
1:5@A4
 Dec 2019
 Fig 28

Direct Fix Penetration Detail

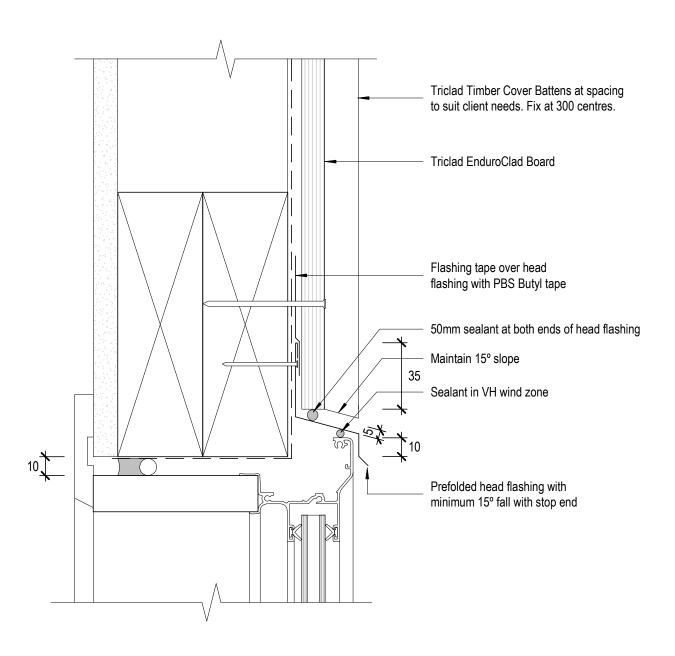
1 : 2 @ A4
 Dec 2019
 Fig 29

Direct Fix Window Head Detail-Aluminium

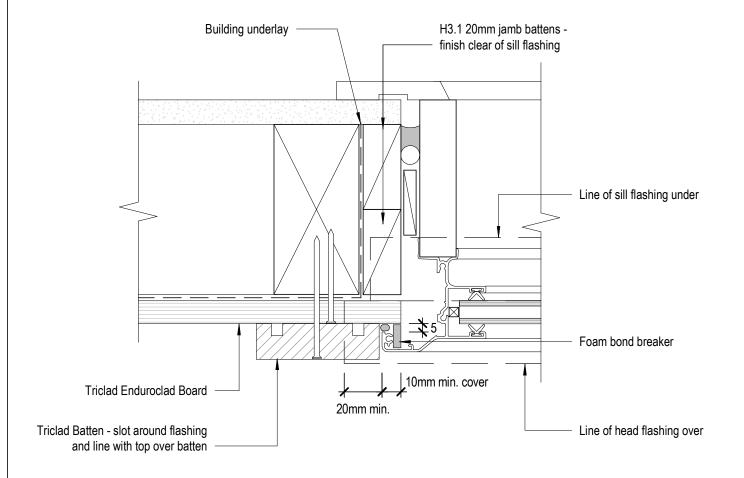
1:2@A4
 Dec 2019
 Fig 30

Direct Fix Window Jamb Detail-Aluminium

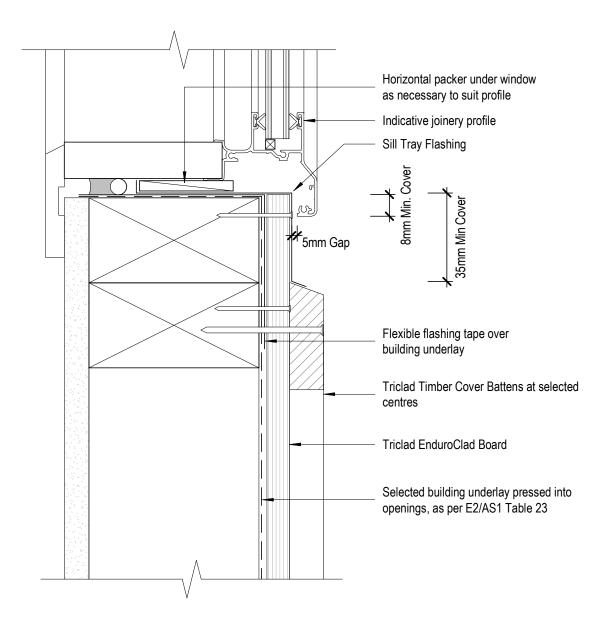
1:2@A4
 Dec 2019
 Fig 31

Direct Fix Window Sill Detail-Aluminium

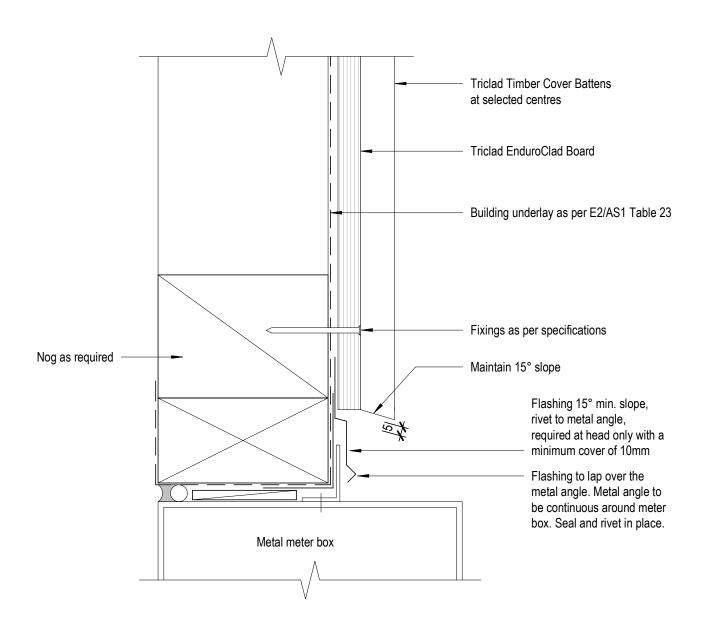
1:2@A4
 Dec 2019
 Fig 32

Direct Fix Meter Box Head

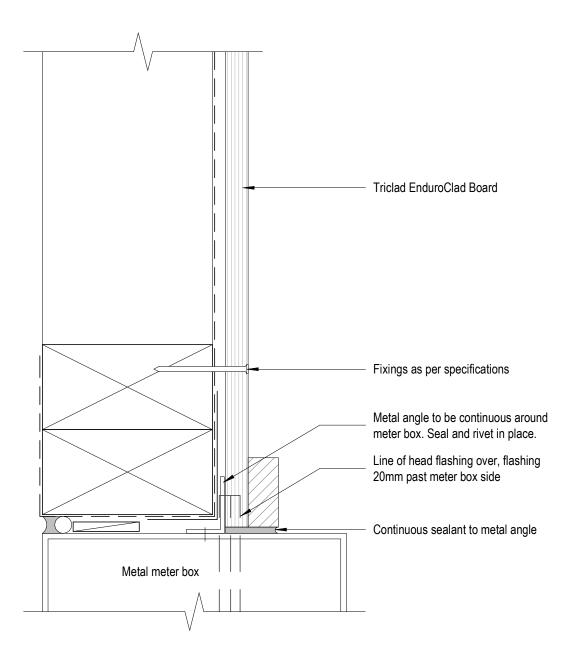
1:2@A4
 Dec 2019
 Fig 33

Direct Fix Meter Box Jamb

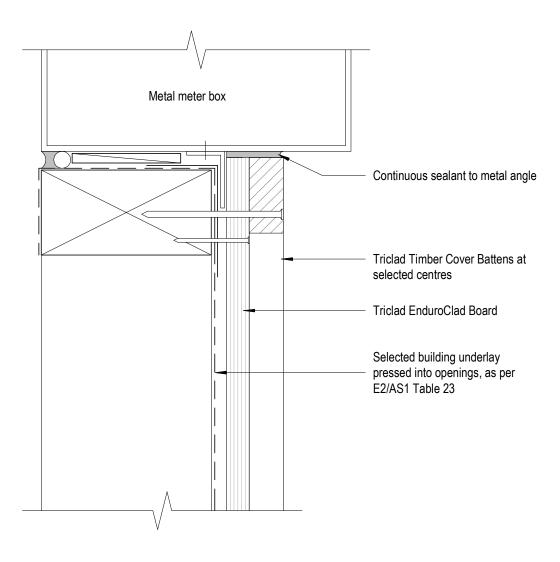
Fig 34

Direct Fix Meter Box Sill

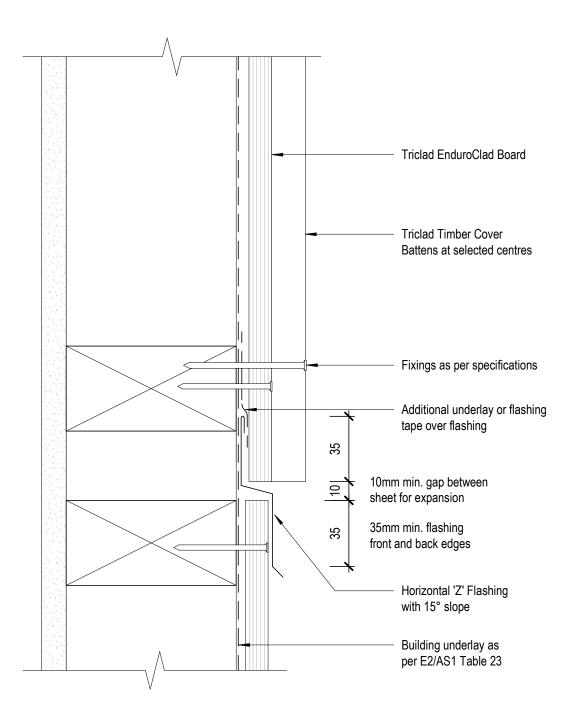
1:2@A4
 Dec 2019
 Fig 36

Direct Fix Horizontal Join Detail

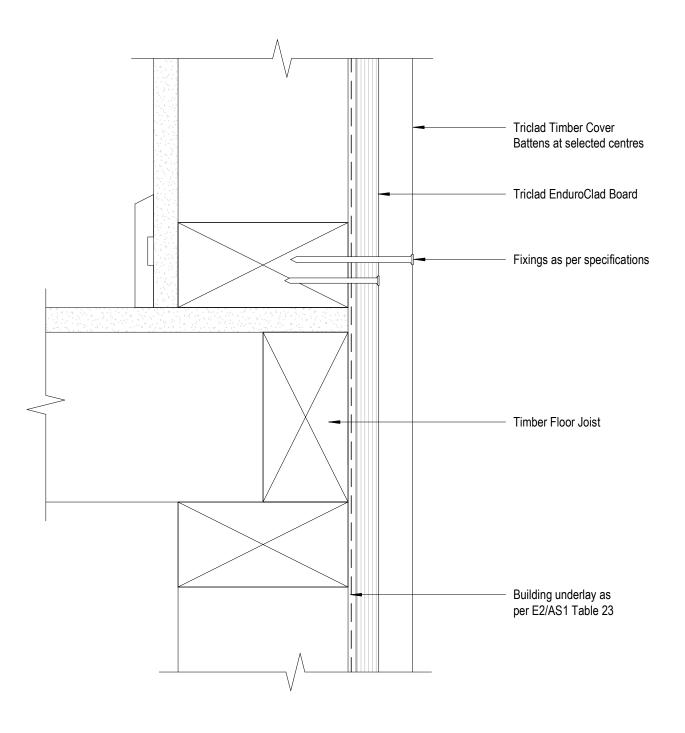
Dec 2019 Date **Fig 36a** Dwg

Direct Fix Inter-Story Detail - No Join
