Cavity Fix Nailing Setout Detail

Cavity Fix Framing/Batten Setout

Direct Fix Nailing Setout Detail

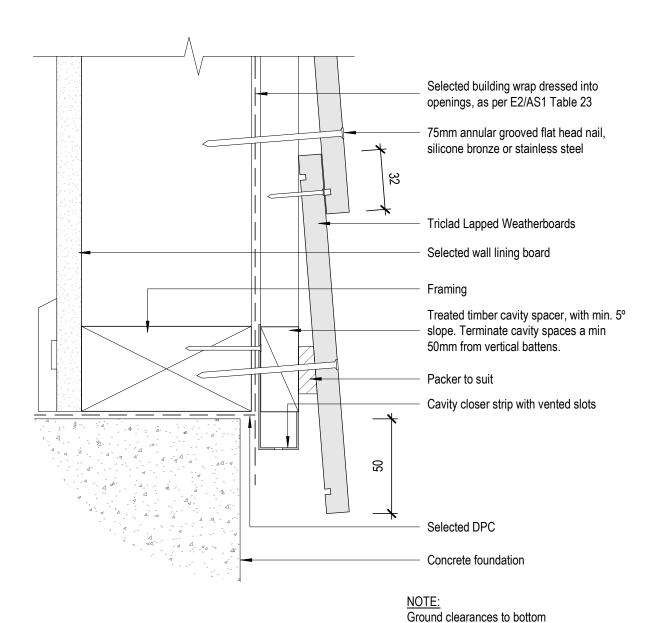
1:2@A4 Scale Sept 2019 Date Fig 3 Dwg

Cavity Fix Base Detail-Concrete Floor

of cladding as per NZS3604:2011

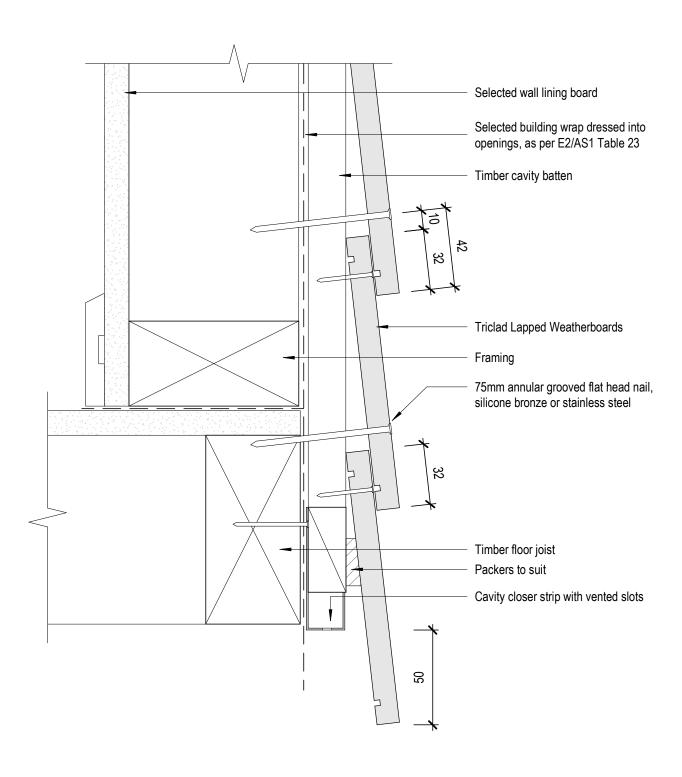
1:2@A4
 Sept 2019
 Fig 4

Cavity Fix Base Detail-Timber Floor

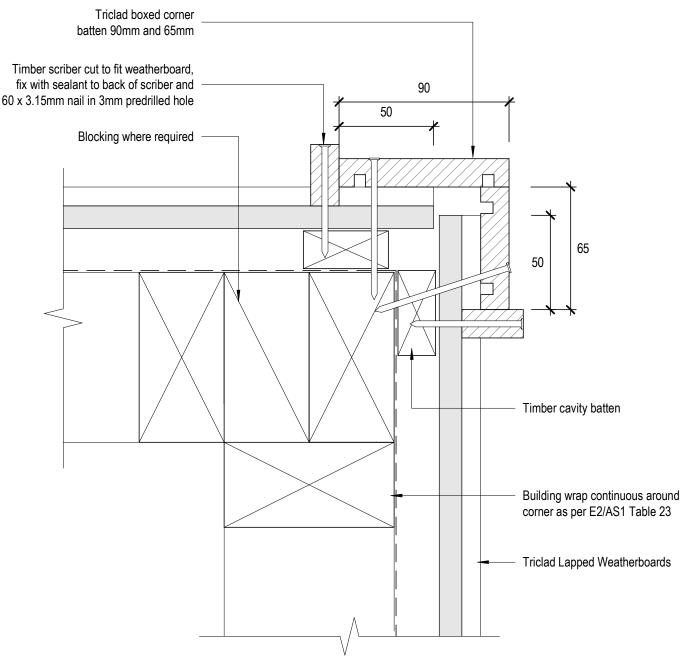
1:2@A4 Scale Fig 5 Dwg

NOTE:
Box corner trim must not be continuous over solid floor joists.

Cavity Fix External Corner-Boxed

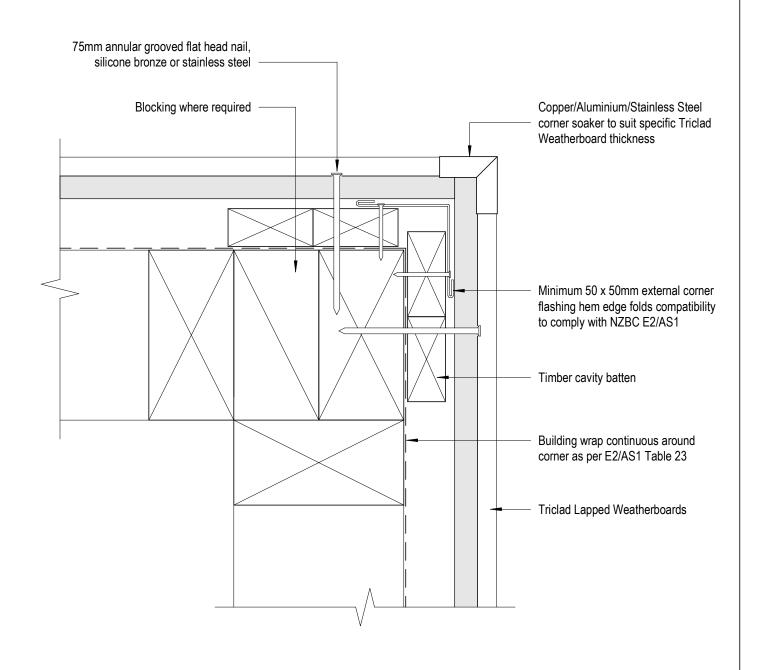
1:2@A4 Scale Sept 2019 Date Fig 6 Dwg

Cavity Fix External Corner-Soaker

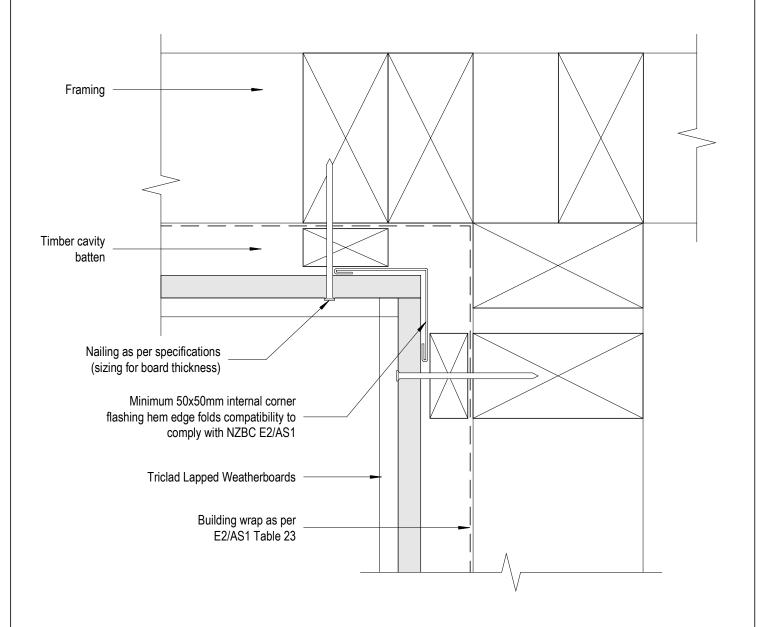
1:2@A4 Scale Sept 2019 Fig 7
Date Dwg

Cavity Fix Internal Corner-Option 1

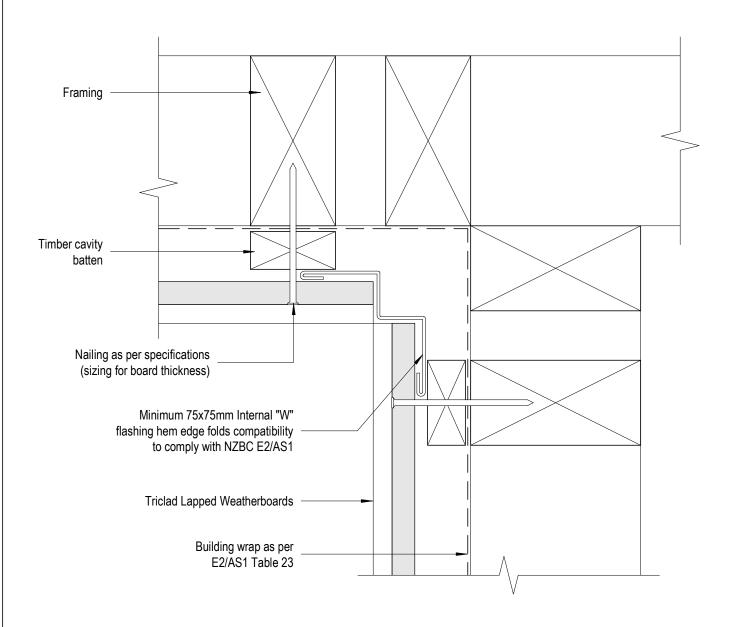
1:2@A4 Scale Sept 2019 Date Fig 8

Cavity Fix Internal Corner-Option 2

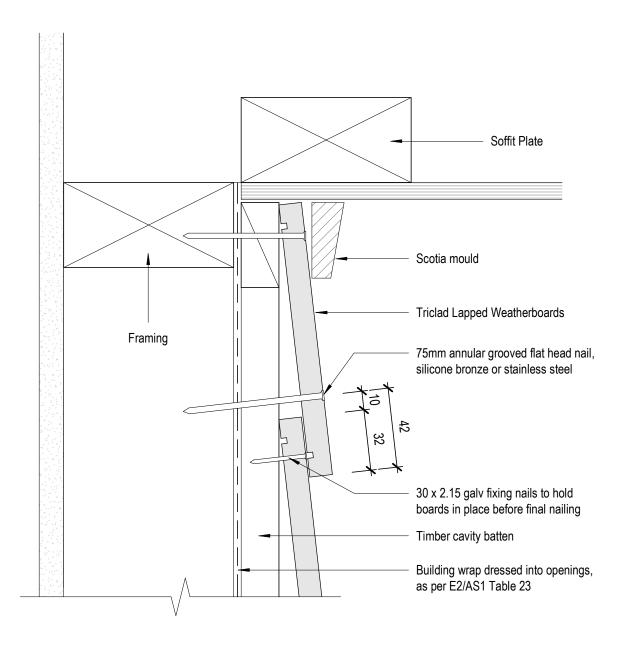
1:2@A4 Scale Sept 2019 Date Fig 9

Cavity Fix Soffit Detail

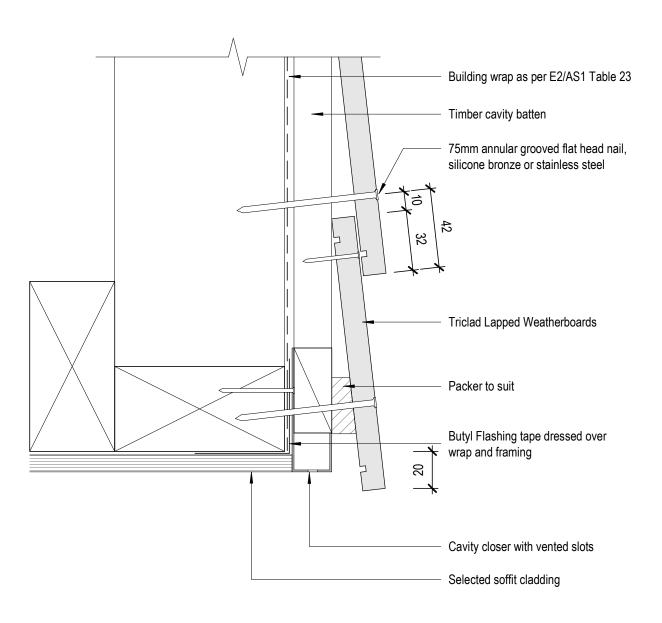
1:2@A4 Scale Sept 2019 Date Fig 10 Dwg

Cavity Fix Soffit/Beam Detail

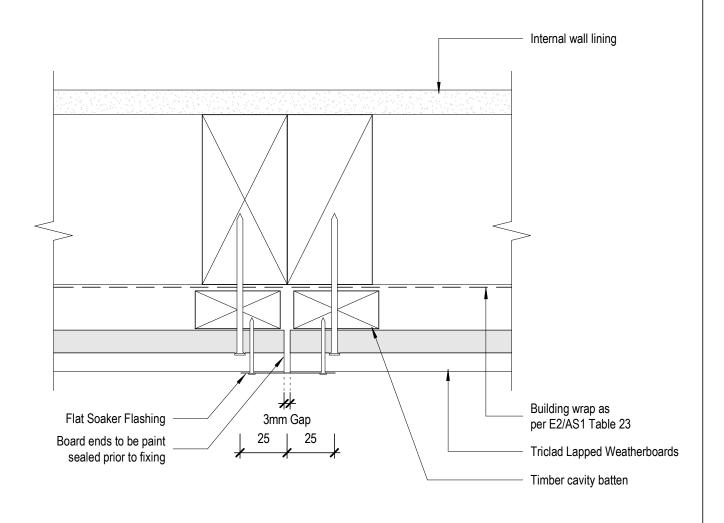
1:2@A4 Scale Sept 2019 Date **Fig 11** Dwg

Cavity Fix Board Joint Detail

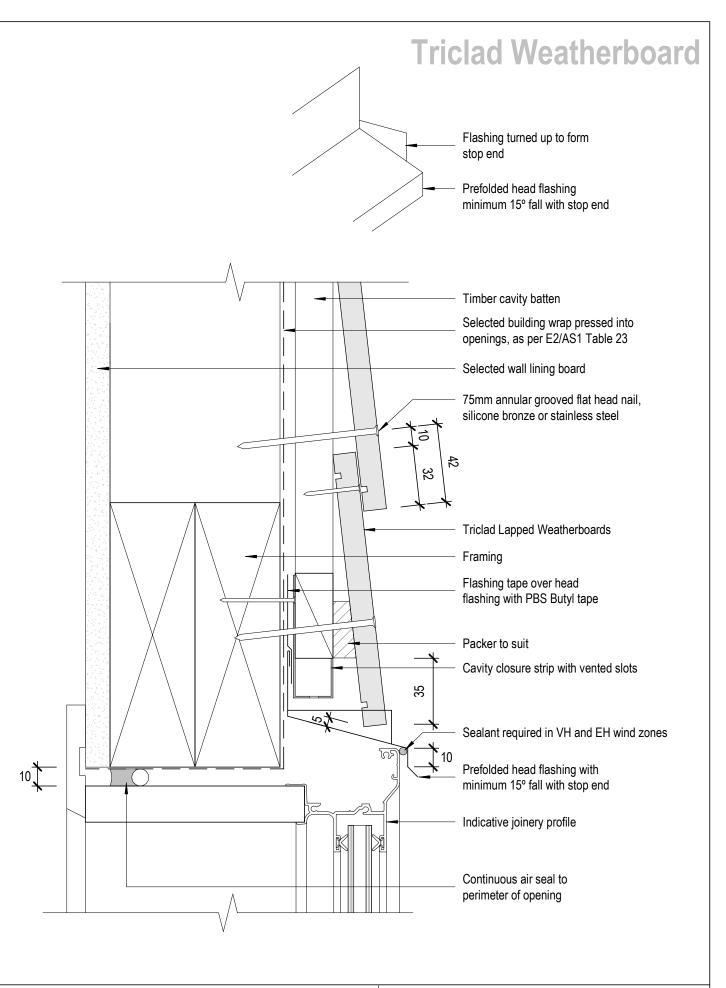
1:2@A4
 Sept 2019
 Fig 12

Cavity Fix Window Head Detail-Aluminium

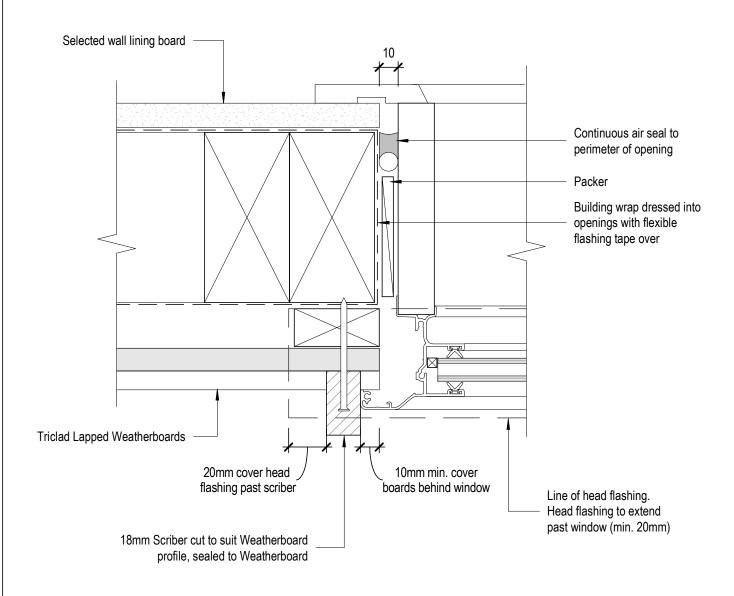
Sept 2019 Fig 13 Dwg

Cavity Fix Window Jamb Detail-Aluminium

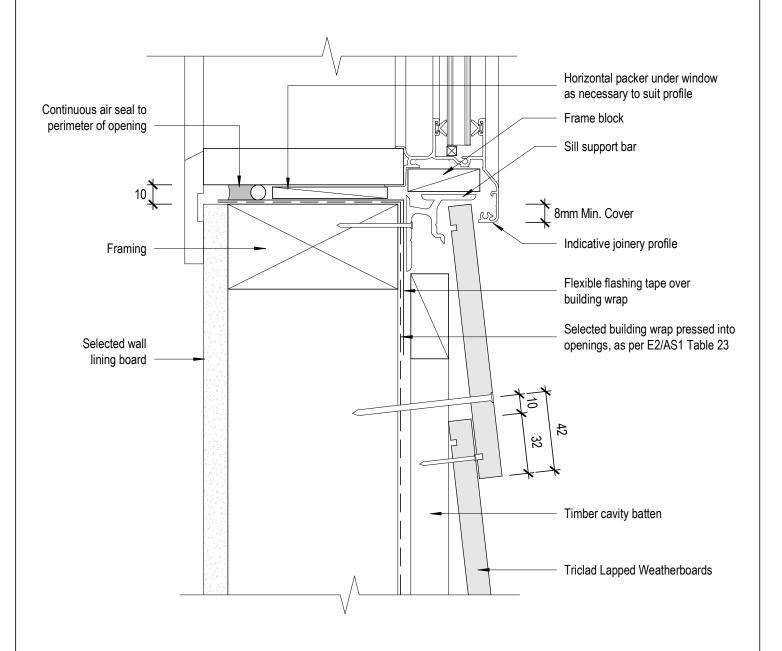
Fig 14 Dwg

Cavity Fix Window Sill Detail-Aluminium

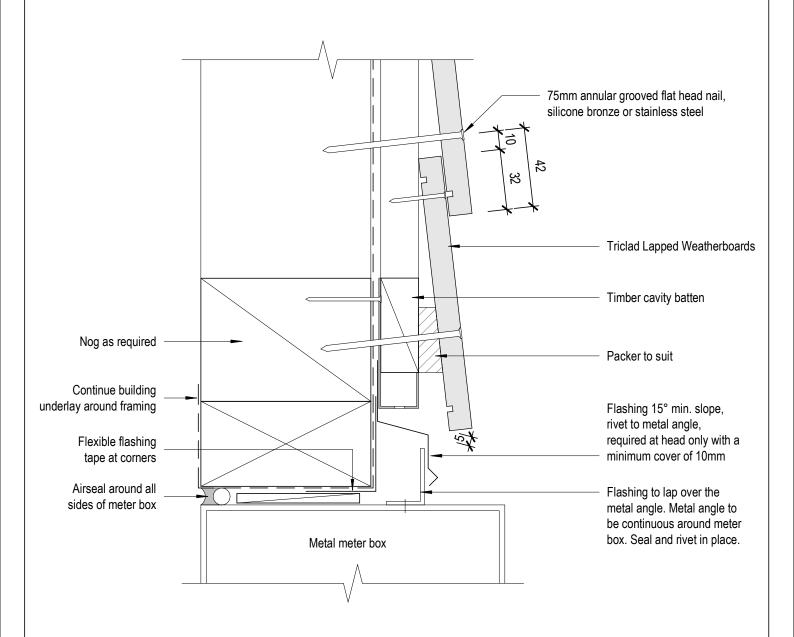
Sept 2019 Date Fig 15 Dwg

Cavity Fix Meter Box Head

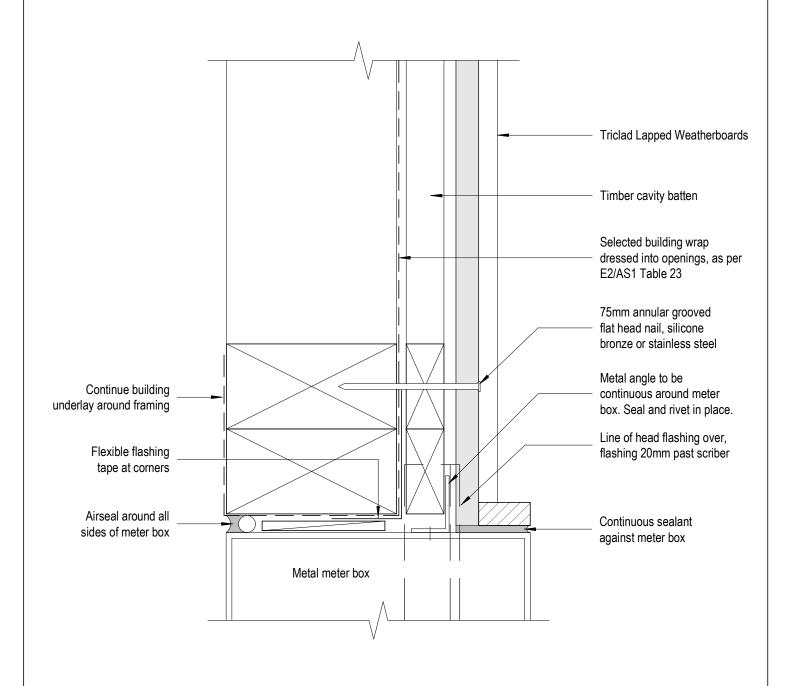
Fig 16 Dwg

Cavity Fix Meter Box Jamb

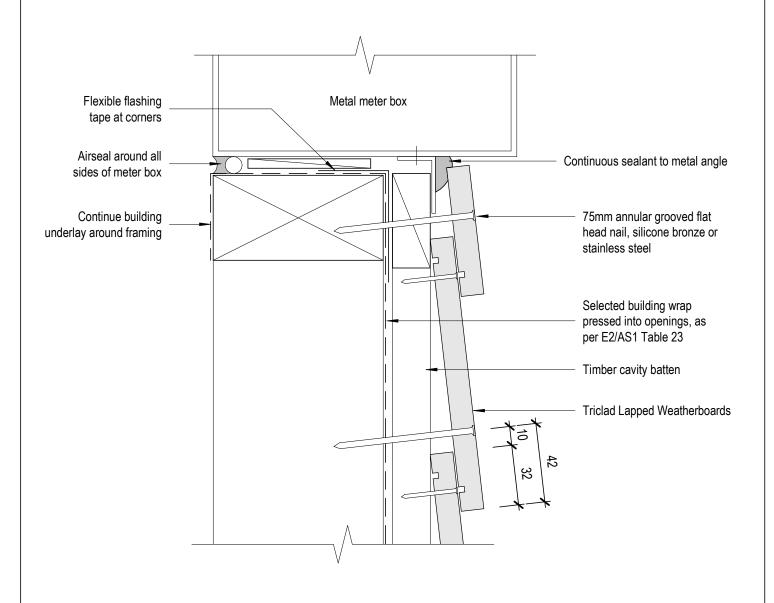
Fig 17

Cavity Fix Meter Box Sill

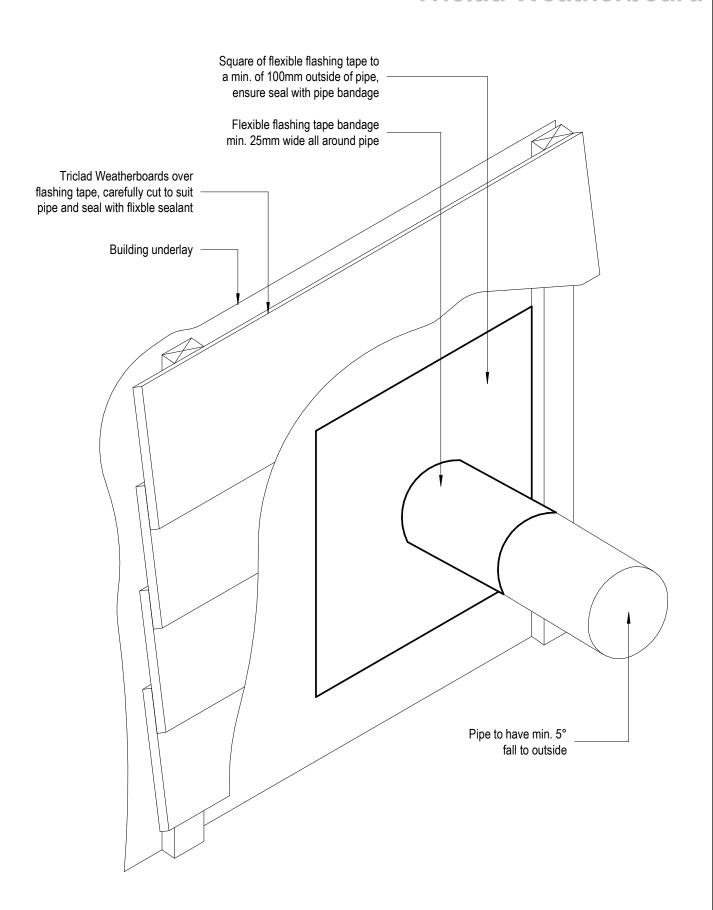
1:5@A4 Scale Sept 2019 Date Fig 18 Dwg

Cavity Fix Penetration Detail

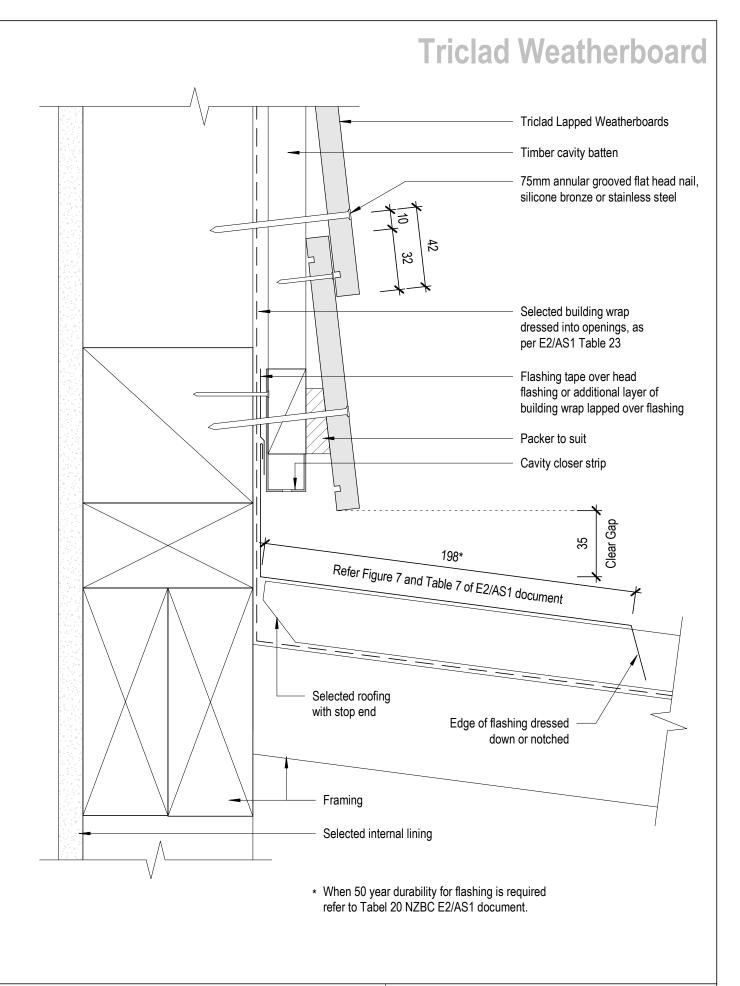
Fig 19 Dwg

Cavity Fix Roof/Wall Detail

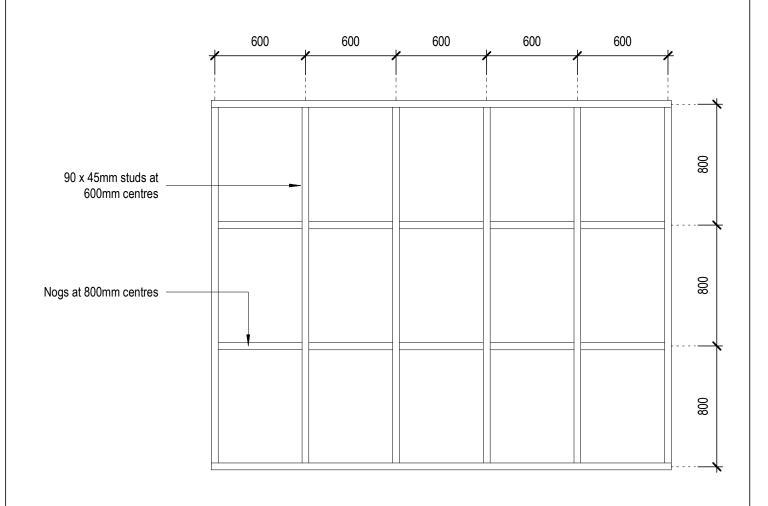
1:25 @ A4 Scale Sept 2019 Fig 21
Date Dwg

Direct Fix Framing/Batten Setout

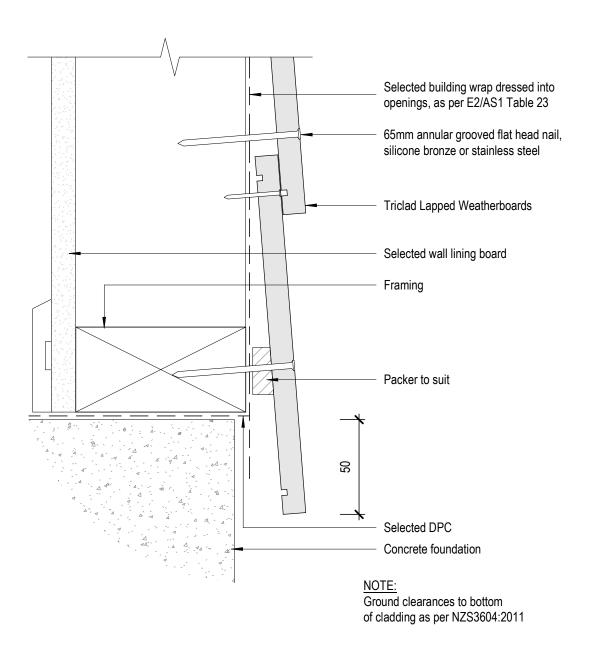
Fig 22 Dwg

Direct Fix Base Detail-Concrete Floor

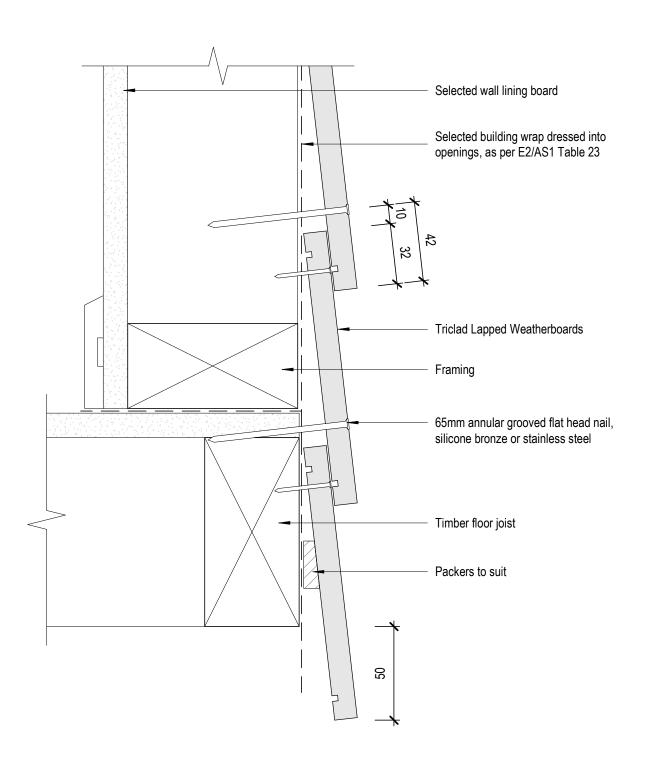
1:2@A4 Scale Sept 2019 Fig 23
Date Dwg

Direct Fix Base Detail-Timber Floor

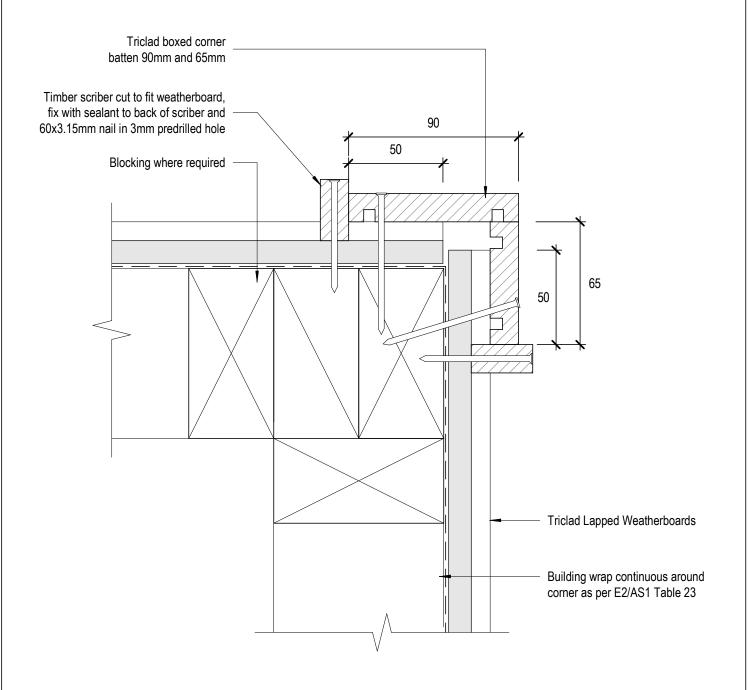
1:2@A4 Scale Sept 2019 Fig 24
Date Dwg

Direct Fix External Corner-Boxed

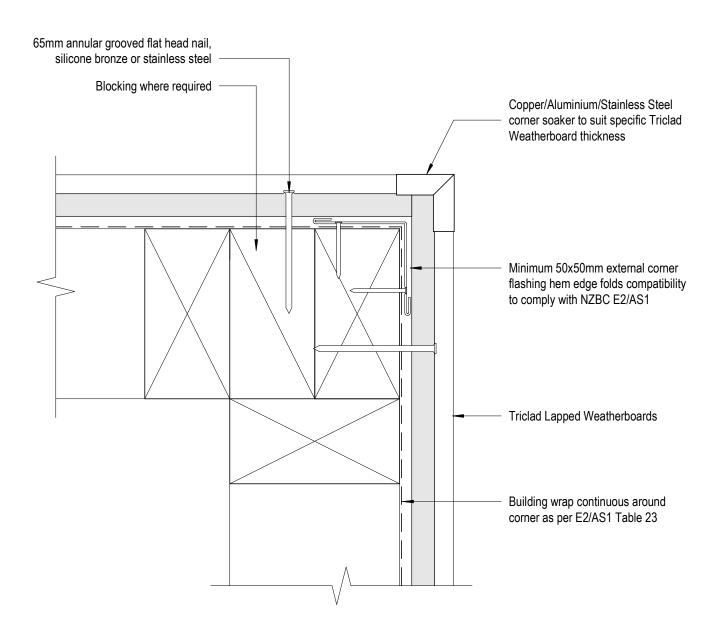
Fig 25 Dwg

Direct Fix External Corner-Soaker

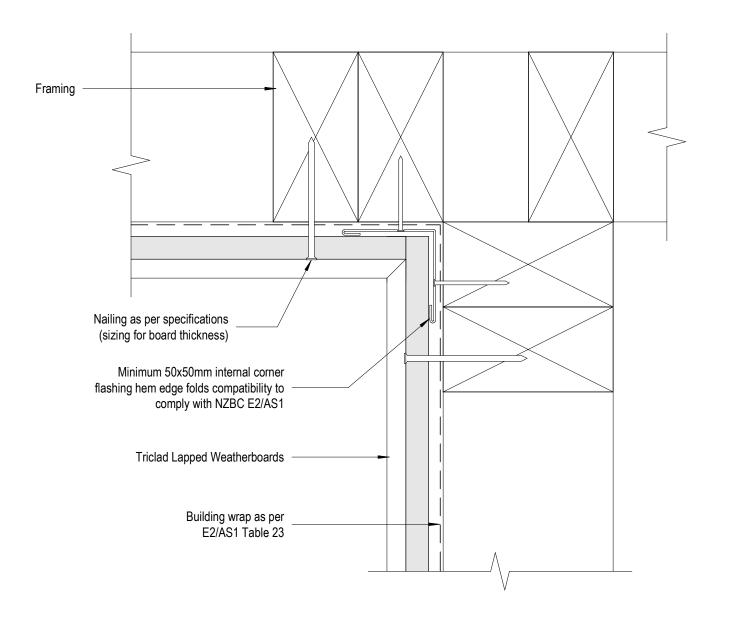
1:2@A4 Scale Sept 2019 Date **Fig 26** Dwg

Direct Fix Internal Corner-Option 1

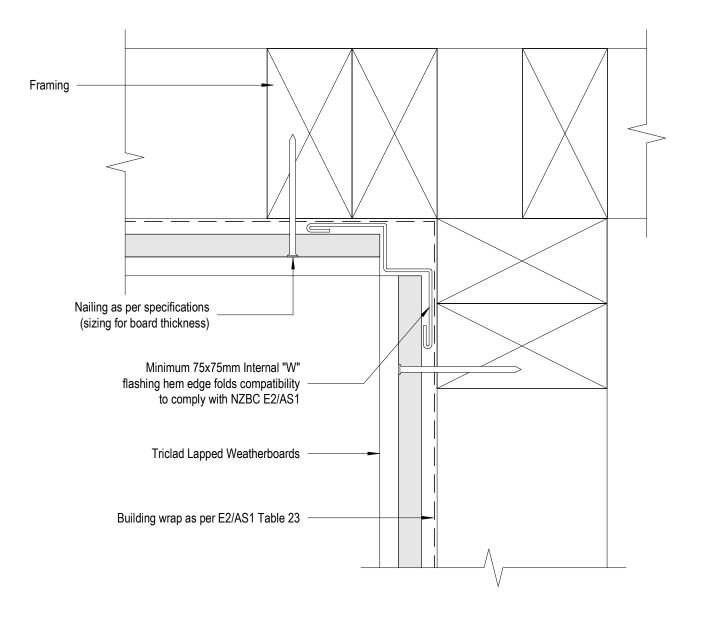
1:2@A4 Scale Sept 2019 Date Fig 27

Direct Fix Internal Corner-Option 2

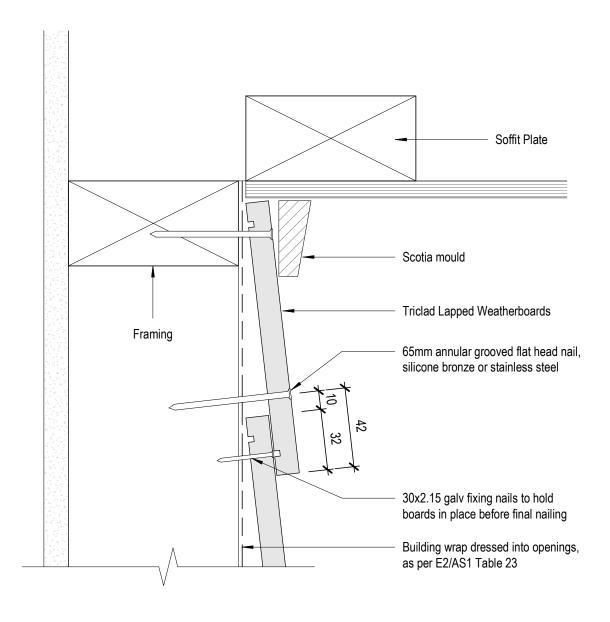
Sept 2019 Fig 28
Date Dwg

Direct Fix Soffit Detail

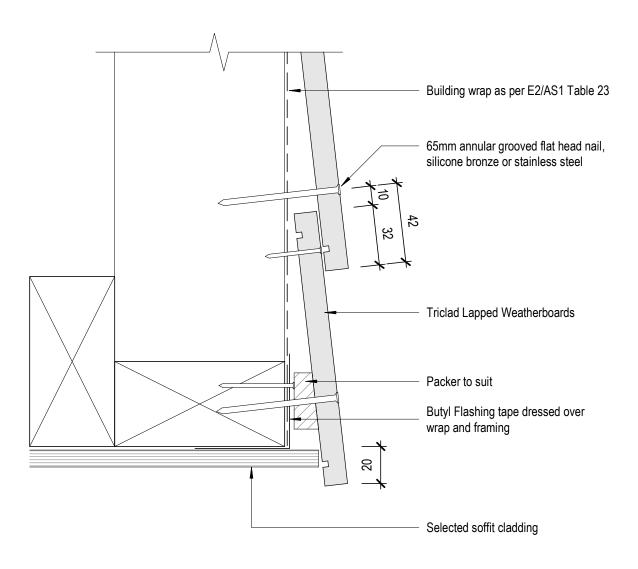
1:2@A4 Scale Sept 2019 Date Fig 29 Dwg

Direct Fix Soffit/Beam Detail

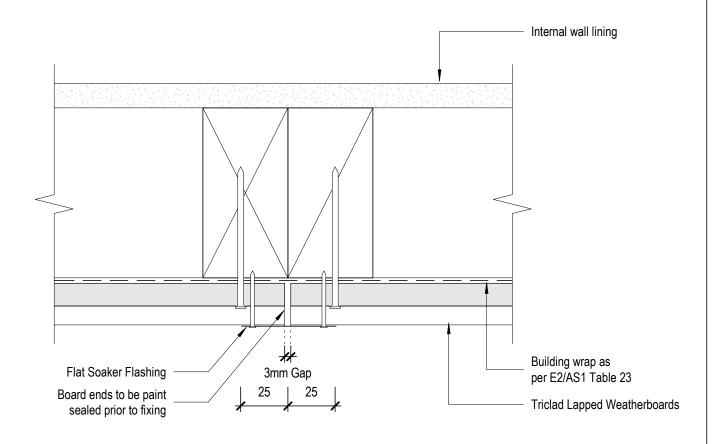
1:2@A4 Scale Sept 2019 Date Fig 30 Dwg

Direct Fix Board Joint Detail

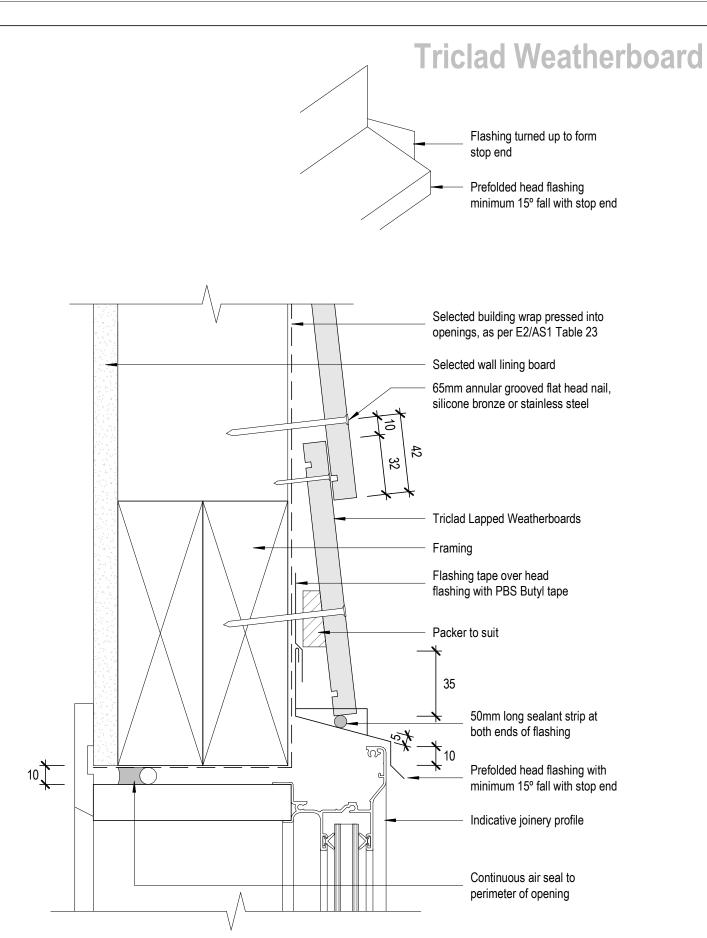
1:2@A4 **Sept 2019** Fig 31 Dwg

Direct Fix Window Head Detail-Aluminium

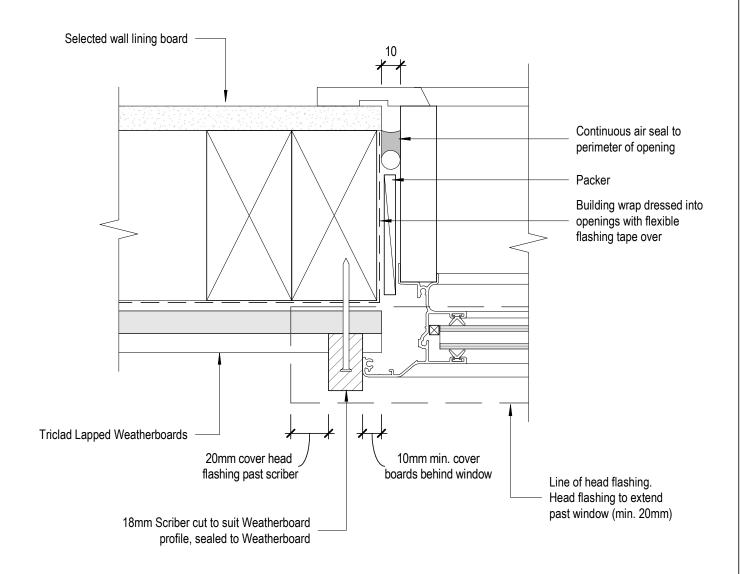
1:2@A4 Scale Sept 2019 Fig 32
Date Dwg

Direct Fix Window Jamb Detail-Aluminium

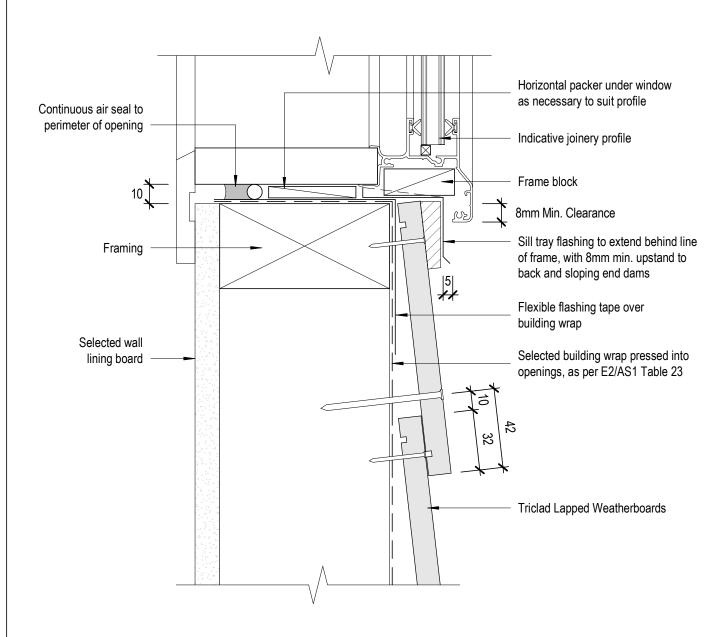
1:2@A4 Scale Sept 2019 Fig 33
Date Dwg

Direct Fix Window Sill Detail-Aluminium

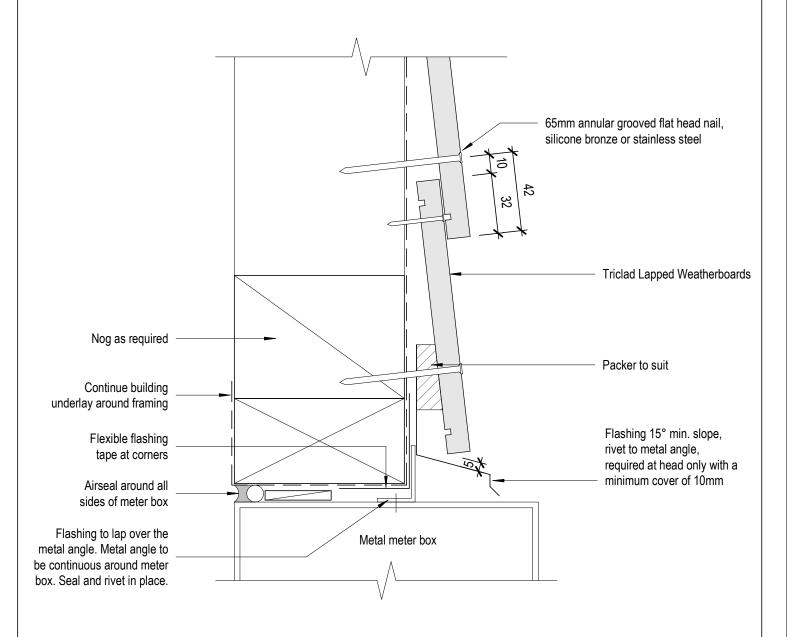
1:2@A4 Scale Sept 2019 Date Fig 34 Dwg

Direct Fix Meter Box Head

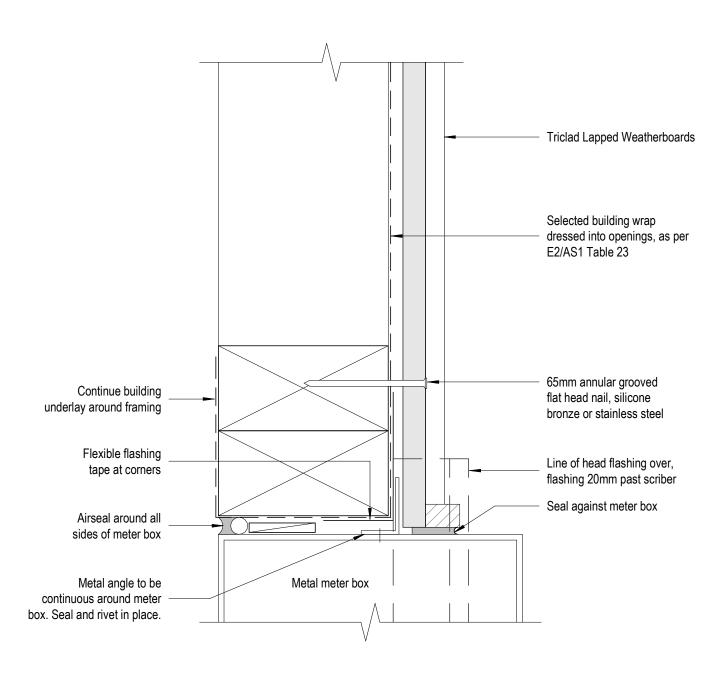
Sept 2019 Date Fig 35

Direct Fix Meter Box Jamb

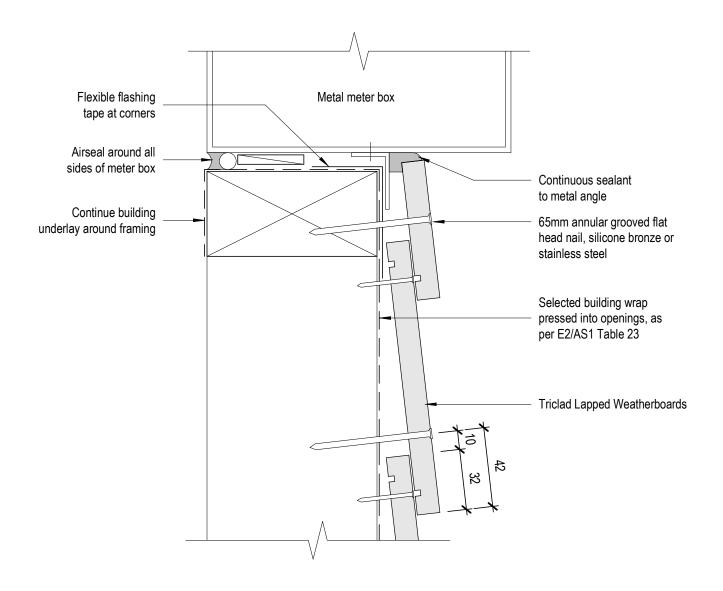
1:2@A4 Scale Sept 2019 Fig 36
Date Dwg

Direct Fix Meter Box Sill

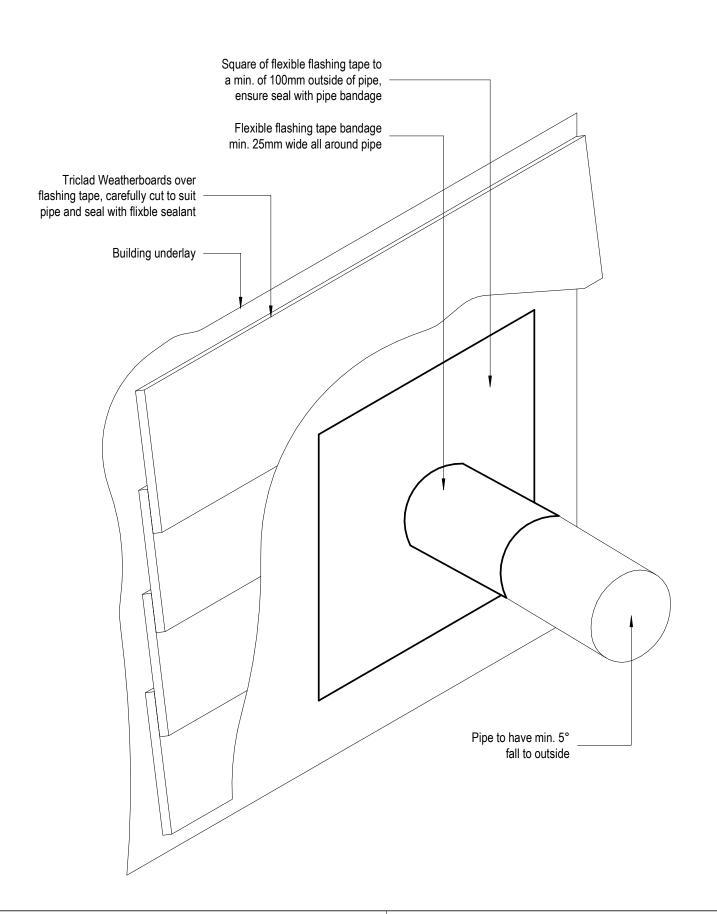
Fig 37

Direct Fix Penetration Detail

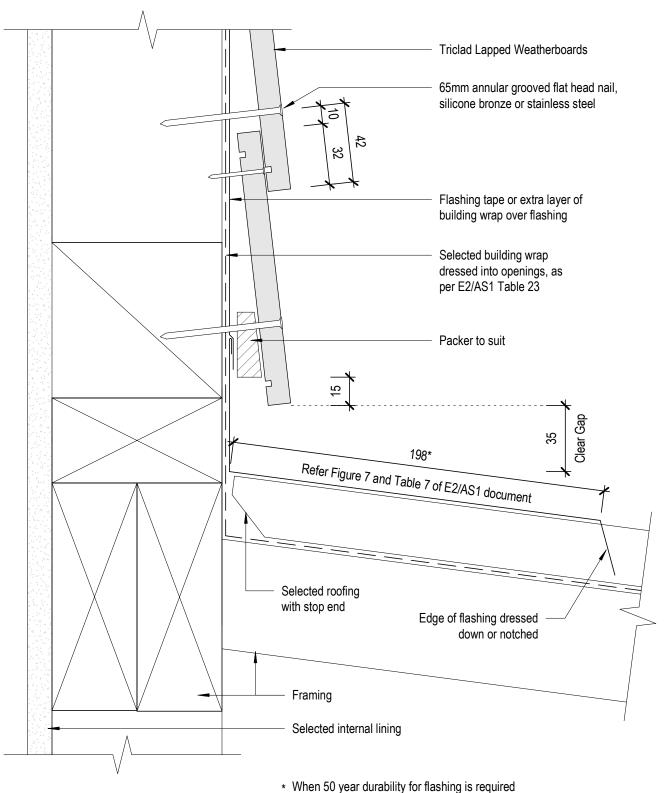
1:2@A4 Scale Sept 2019 Fig 38
Date Dwg

When 50 year durability for flashing is required refer to Tabel 20 NZBC E2/AS1 document.

Direct Fix Roof/Wall Detail
